# Technical Bulletin

**87 16 10 July 7, 2016 2040184** Supersedes Technical Bulletin V871608 dated June 22, 2016 to update to the latest SW level 0202 released CW23/16 and update GFF time expenditure.

**Climatronic with Heat Pump - Sporadically Too Low Heating or Cooling Performance**

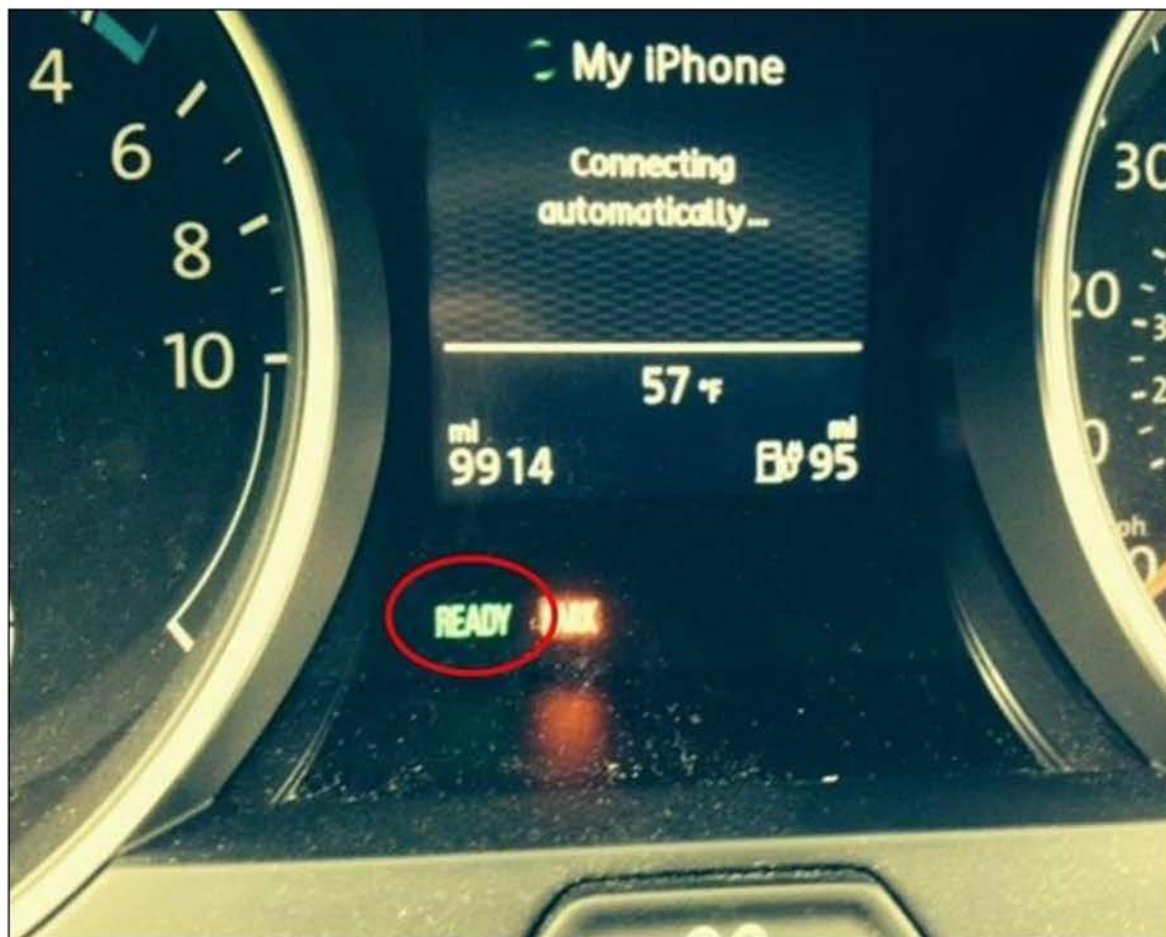
Figure 1

**After the software update an initial run of the compressor must be carried out according to the Guided Functions. The start switch must be ON, brake pedal depressed and electric motor indicator in the instrument panel in READY status (Figure 1). The initial run of the compressor will not complete without READY status illuminated.**
