# Technical Bulletin

| Model(s) | Year | Eng. Code | Trans. Code | VIN Range From | VIN Range To |
|---|---|---|---|---|---|
| e-Golf | 2015 | All | All | All | All |

**91 16 05** August 9, 2016 **2040330** Supersedes Technical Bulletin V911504 dated April 29, 2015 to update software level.

### Modular Infotainment System (MIB) Display Shows Fuel Pump Icon after J794 Module Replacement

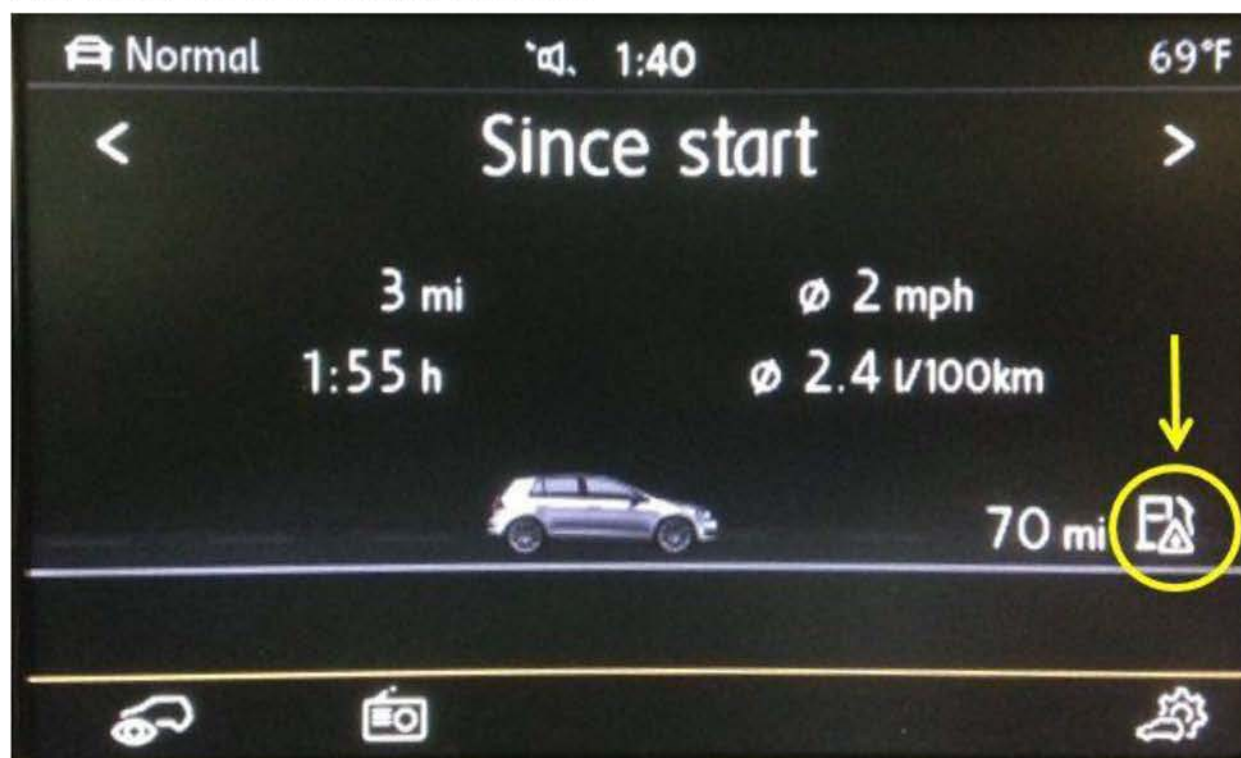
The customer may complain that after a repair involving replacement of the 5F Information Electronics Module J794, that the icon in the lower right hand side of the "Car" menu on the MIB display shows the image of a fuel pump instead of an electric charging station icon.

This procedure corrects the concern listed above by updating the 5F Information Electronics Module to software **E5140**.
