# Technical Bulletin

94 16 01 August 8, 2015 6 2011521 Supersedes Technical Bulletin V941502 dated October 28, 2015 to include additional model and model year applicability.

### Exterior Lights, Moisture Accumulation

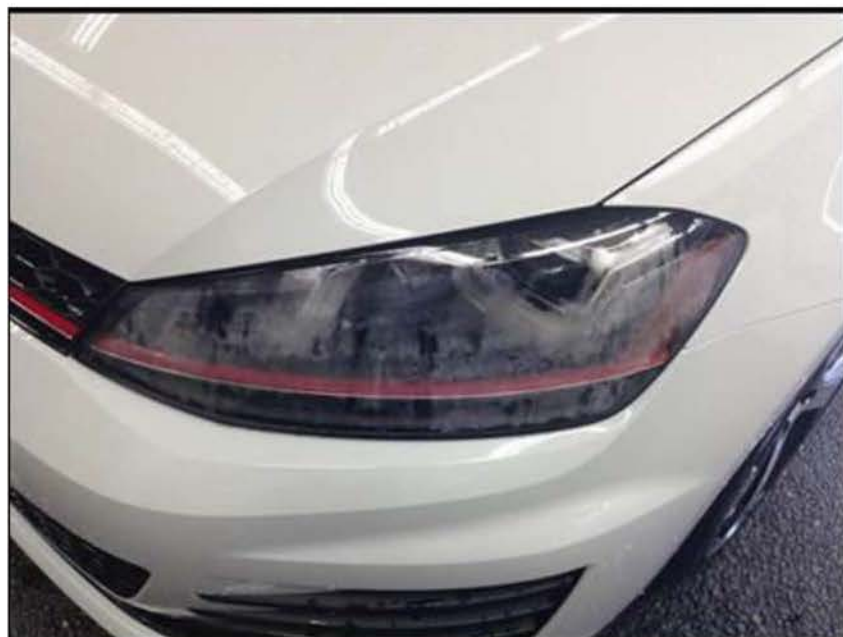
Figure 1

Exterior light assemblies (headlights, taillights, fog lights, turn signals) are vented and may collect moisture on their inner surfaces, depending on humidity and climatic conditions. The unfavorable condensation built up (Figure 1) visible to the customer is more common with modern exterior lights because of clear glass optics, however this condition will not have an impact on the functionality or durability of the component.

**For headlight condensation that is due to environmental conditions, the affected lens surface should be cleared after approx. 30 minutes of light operation.**

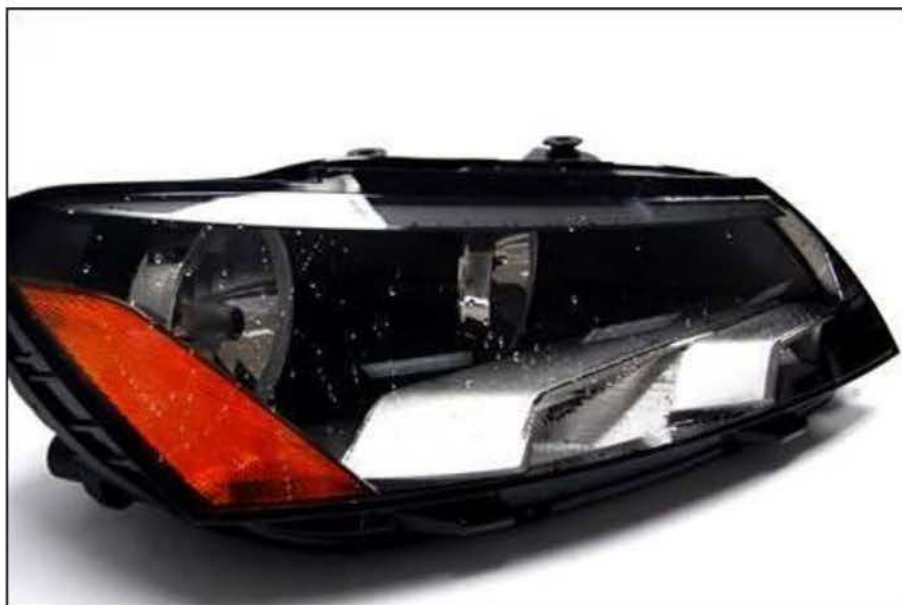
Figure 2

In cases where larger water droplets have formed on the inside of the lens or significant amount of water has collected at the bottom of a light assembly, Figure 2:

- Check for leaking seals, cracks in lenses or assemblies.

**DO NOT** replace light or lens assemblies unless damage is found.

If damage to seals or cracks to lenses or assemblies are found:

- Follow normal repair procedures for this type of failure (provide photograph(s) with repair documentation for verification).
