# Technical Bulletin

**46 16 07** August 23, 2016 **2015173** Supersedes Technical Bulletin V461605 dated May 4, 2016 to include model year 2017 applicability.

### Brake Disc Pulsation or Vibration (U.S. Only)

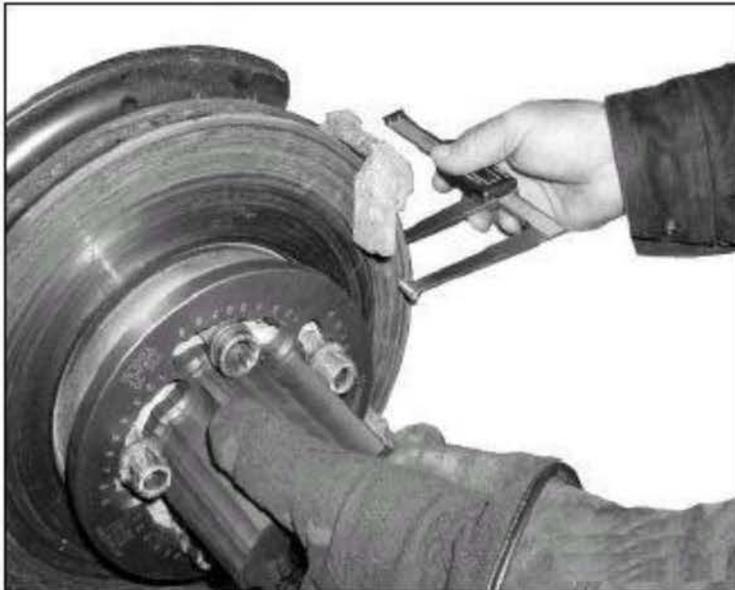
- Inspect brake disc friction surfaces on both sides of the brake disc for:
  - Severe discoloration (bluing)
  - High heat surface damage (raised hard spots)
  - Visible cracks

Brake discs showing any of the above described conditions are **NOT** serviceable. Parts must be replaced in accordance with the Volkswagen Warranty Policy and Procedure Manual.

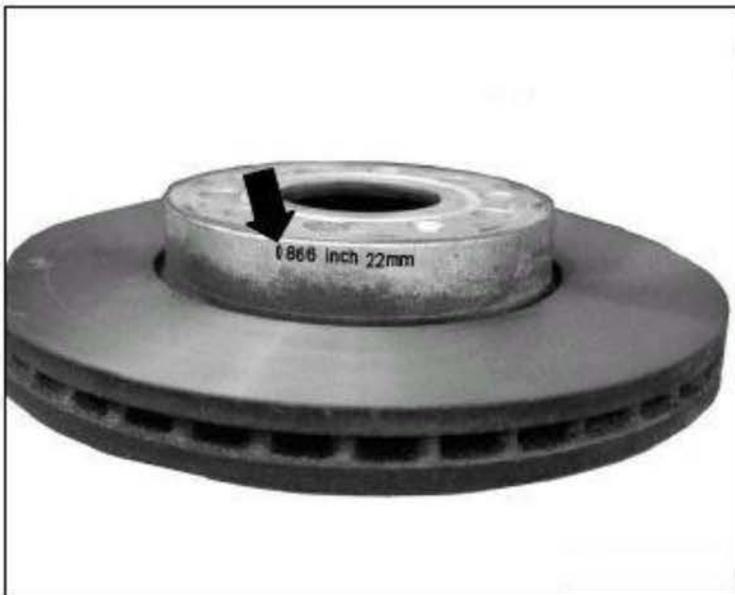
- Measure the brake disc thickness in 4 locations using either the Pro Cut International™ disc thickness measuring tool Part No. 50-902 or the Hunter Engineering Company disc thickness measuring tool Part No. 25-99-2. Measurements **MUST** be taken at the same distance from the brake disc outer circumference to ensure consistency.

The brake disc thickness measurement must exceed the minimum specification after the machining process is completed in order to be re-used. If the brake disc thickness measurement does not meet this requirement, then replace the brake disc.

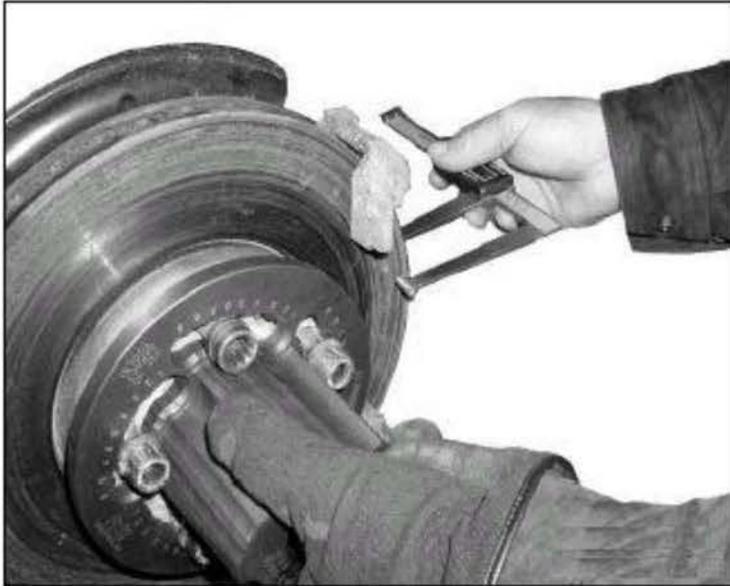
- Re-measure brake disc thickness in 4 locations using either the Pro Cut International™ disc thickness measuring tool Part No. 50-902 or the Hunter Engineering Company disc thickness measuring tool Part No. 25-99-2. If recorded brake disc measurement is less than the minimum thickness, the brake disc **MUST** be replaced.

Always replace brake discs in pairs (front axle or rear axle). Do not replace all 4 brake discs unless it is required.

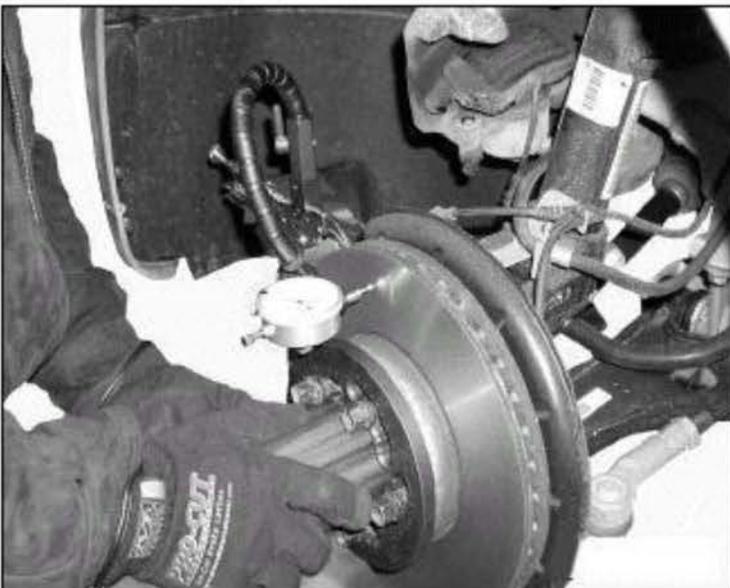
- Measure brake disc lateral run out using Pro Cut Disc Lateral run out measuring kit Part No. 50-700FC or the Hunter Disc Lateral run out measuring kit Part No. 25-128-2 with a dial indicator.
- Run out must not exceed 0.1mm.
- If brake disc exceed the 0.1mm specification replace the applicable brake discs.
