QUARANTINE NOTICE

Reference number:	QN-08-0042	Issued: 24 November 2016
Subject:	Fluid Leakage from the Clutch Slave Cylinder	
Model(s):	V8, V12 Vantage, GT8 and GT12, ASM Transmission only	
VIN range:	Refer to separately published VIN list	
Applicable to:	All Dealers	
Distribute to:	After Sales Manager Executive Manager Service Manager Sales Manager	Warranty Staff Technician(s) Parts Staff

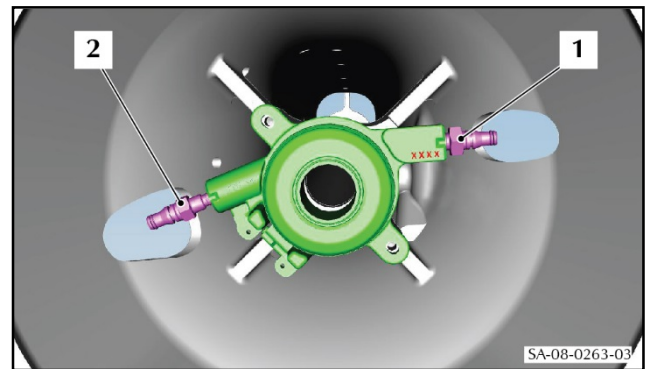
Figure 6

There is a small quantity of V8 and V12 Vantage and GT12 ASM transmission vehicles that can have a problem with the fluid connections on the clutch slave cylinder. It is possible that the connectors are not correctly tightened and fluid can leak.

- 8. Torque the fluid pressure connector (1) to 17.5 Nm (refer to Figure 6).
- 9. Torque the fluid bleed connector (2) to 7.5 Nm.
