FORD:

2014-2016 Fusion

TSB 16-0112 (Continued)

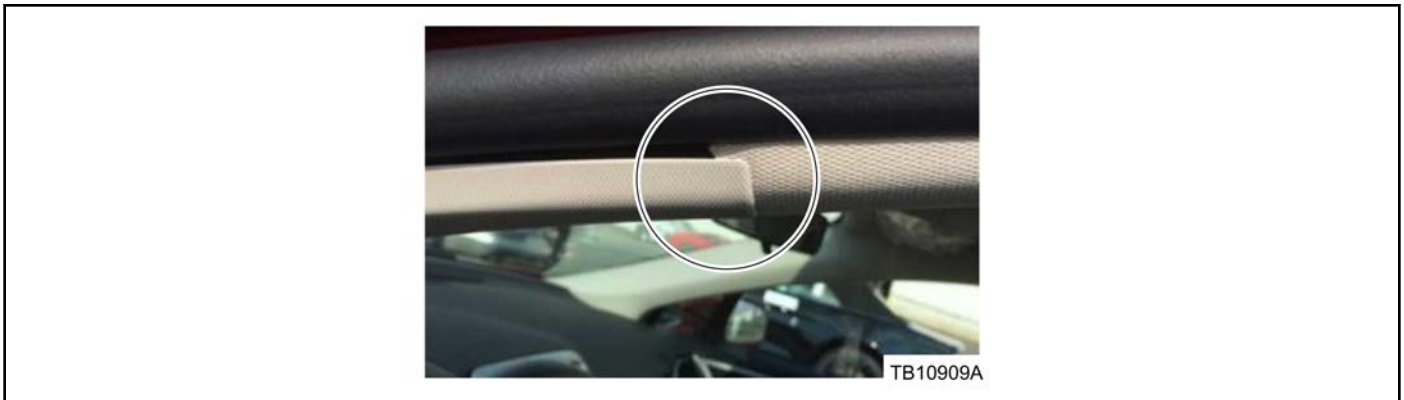
Figure 1 - Article 16-0112

Some 2014-2016 Fusion vehicles built at the Flat Rock assembly plant and built on or before 26-Aug-2016 may exhibit an A-pillar trim panel out of position near the headliner at one or both front doors.

1. Does the vehicle exhibit an A-pillar trim panel out of position near the headliner? (Figure 1)
