**2.3L GASOLINE TURBOCHARGED DIRECT INJECTION (GTDI) -  
ILLUMINATED MALFUNCTION INDICATOR LAMP (MIL) - LACK OF  
POWER - DTC P0299**

**TSB 16-0123**

2015-2016 MKC

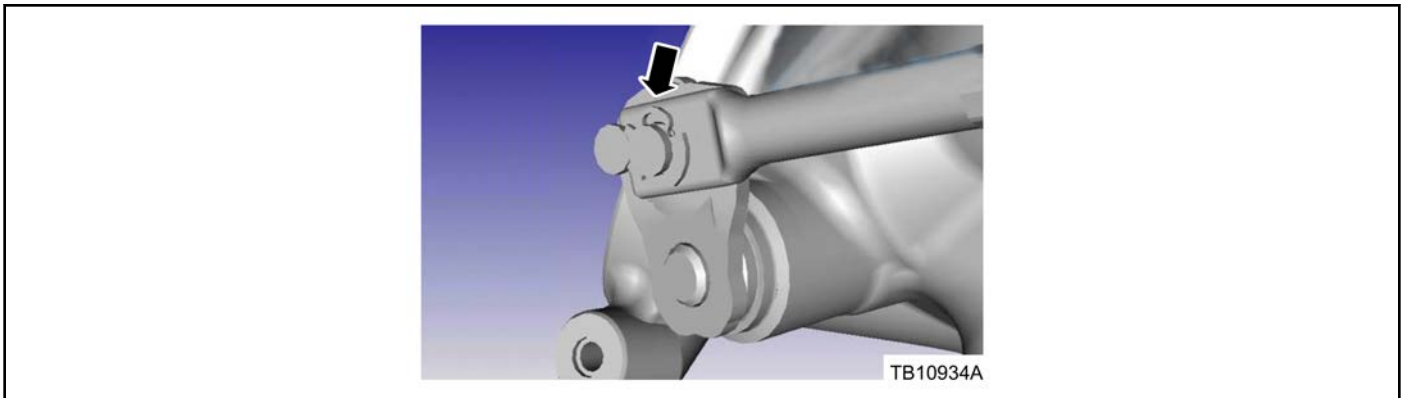
Figure 1 - Article 16-0123

1. Using the Integrated Diagnostic System (IDS) service tool or an equivalent scan tool, check for DTCs. Is DTC P0299 present in the powertrain control module (PCM) memory?
  - a. Yes - proceed to Step 2.
  - b. No - this article does not apply. Refer to Powertrain Control/Emissions Diagnosis (PC/ED) manual for normal diagnostics.
2. Using a long screwdriver, attempt to move the turbocharger wastegate actuator rod to verify proper attachment. Is the turbocharger wastegate actuator rod properly attached and the retaining clip in place? (Figure 1)

9. Position the turbocharger heat shield aside.
10. Reconnect the turbocharger wastegate actuator rod and install a new retaining clip. (Figure 1)
11. Install the turbocharger heat shield.
