SERVICE BULLETIN

Classification: EC16-033	Reference: NTB16-095	Date: October 7, 2016
-----------------------------	-------------------------	--------------------------

2016 TITAN XD; MIL ON WITH DTC P226C OR P0471

APPLIED VEHICLES: 2016 Titan XD (A61)
APPLIED ENGINE: Cummins 5.0L V8 Diesel

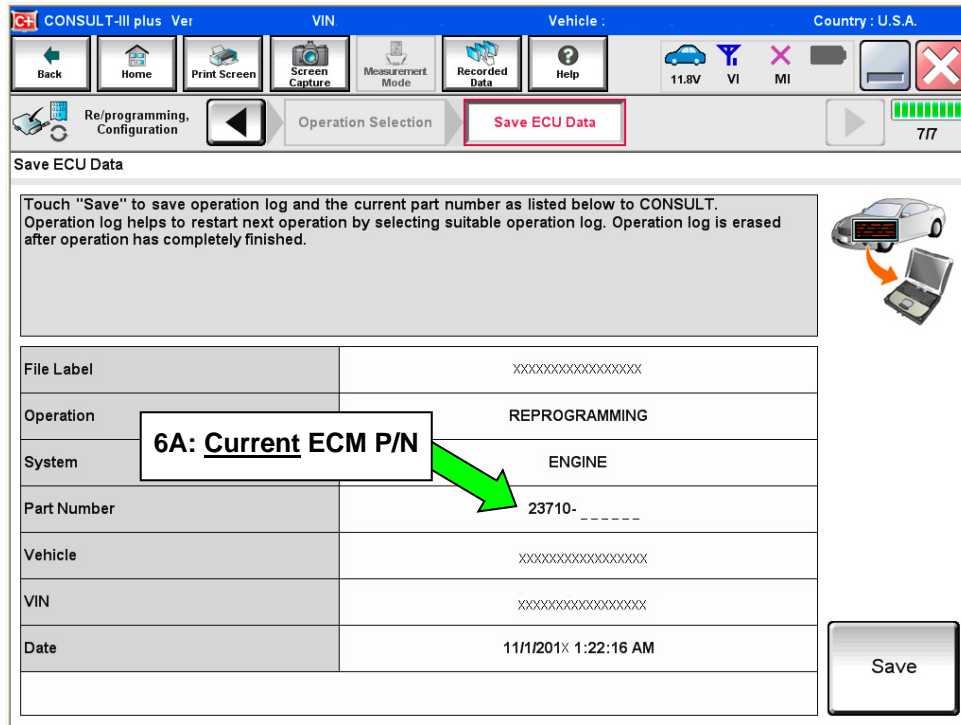
Figure 2

A. Find the ECM **Part Number** and write it on the repair order.

B. Compare the P/N you wrote down to the numbers in the **Current ECM Part Number** column in **Table A** below.

- If there is a match, this bulletin applies. Continue with the reprogramming procedure.
- If there is not a match, this bulletin does not apply. Close C-III plus and refer to ASIST for further diagnostic information.

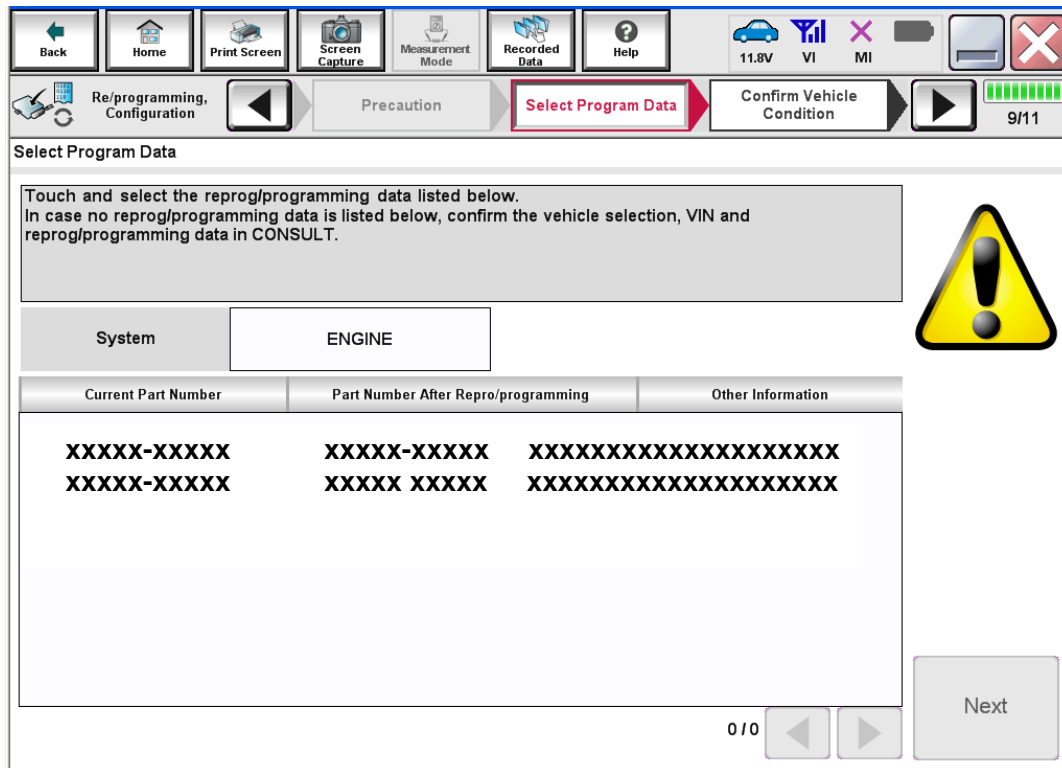
- In some cases, more than one new P/N for reprogramming is available.
 1. If more than one new P/N is available, the screen in Figure 3 displays.
 2. Select and use the reprogramming option that **does not** have the message “Caution! Use ONLY with NTBXX-XXX”.
- If you get this screen and it is blank (no reprogramming listed), it means there is no reprogramming available for this vehicle. Close C-III plus and refer back to ASIST for further diagnosis.

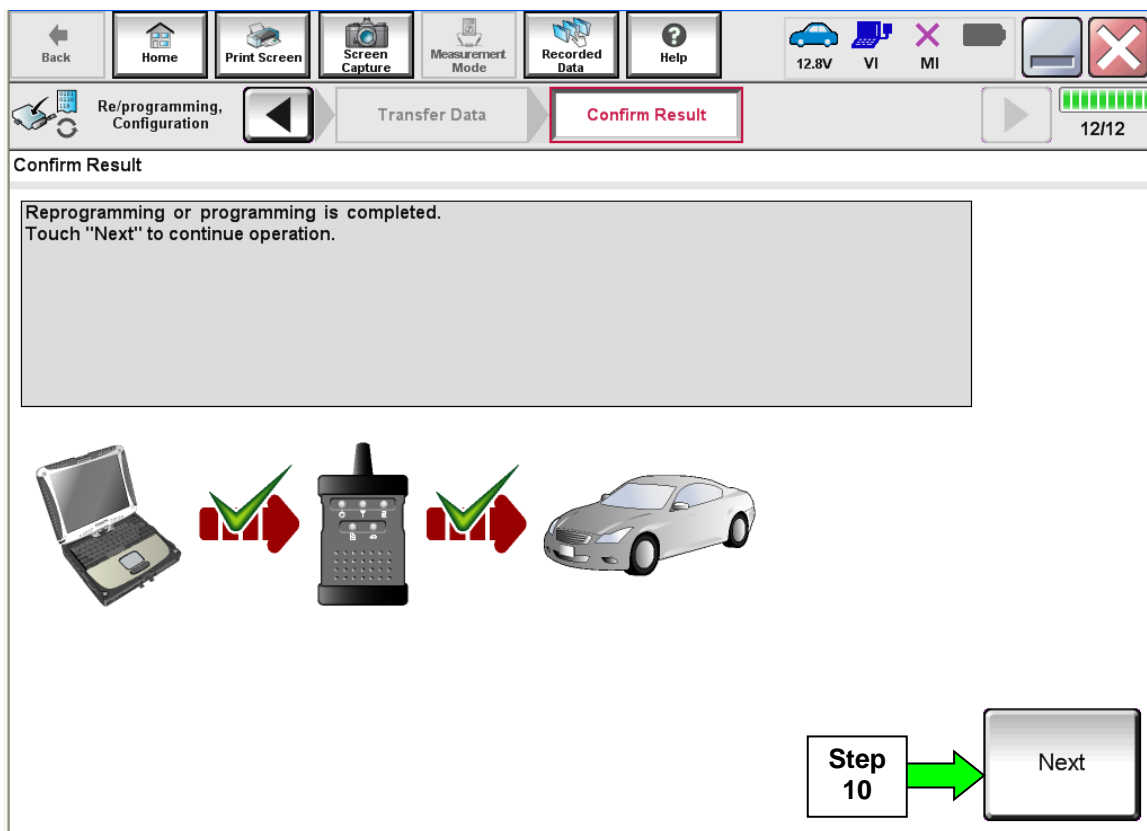
8. When the screen in Figure 4 displays, reprogramming is complete.

NOTE: If the screen in Figure 4 does not display (indicating that reprogramming did not complete), refer to ECM recovery on the next page.
