# QUALITY ACTION

## CAMPAIGN BULLETIN SD Card

Reference: PC481  
Date: October 5, 2016

# PC481 - 2016 MURANO (Z52) NAVI H/U SD CARD

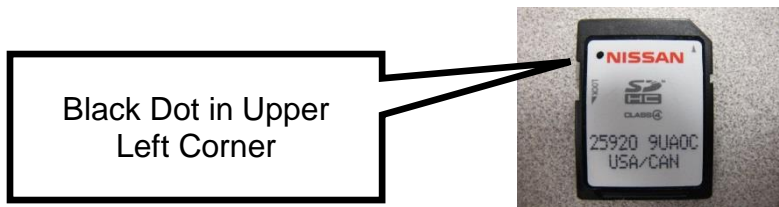
Figure 1

**NOTE:** To complete this repair, a Service SD Card PN **25920-9UA0C** is required. Verify there is a black dot in the upper left corner (Figure 1).
