MODEL
2017MY
Sportage (QL)

NUMBER
153

TECHNICAL SERVICE BULLETIN

SUBJECT: SERVICE ACTION: FRONT POWER SEAT BACK BOARD STRAP REPOSITIONING (SA249)

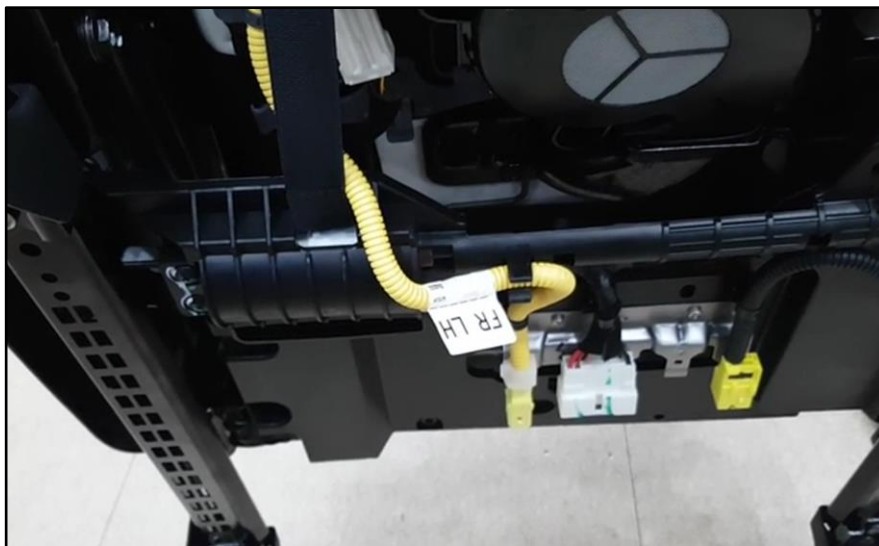
This bulletin provides information related to the repositioning of the front power seat back board strap for 2017MY Sportage (QL) vehicles produced from December 10, 2015 through October 10, 2016 due to interference between the side air bag harness and front seat back board strap. This interference may cause a noise when moving the front seat forward/backward and up/down. Kia is requesting the completion of this Service Action on all affected vehicles in dealer stock prior to delivery. Before conducting the procedure, verify the vehicle is included in the list of affected VINs.

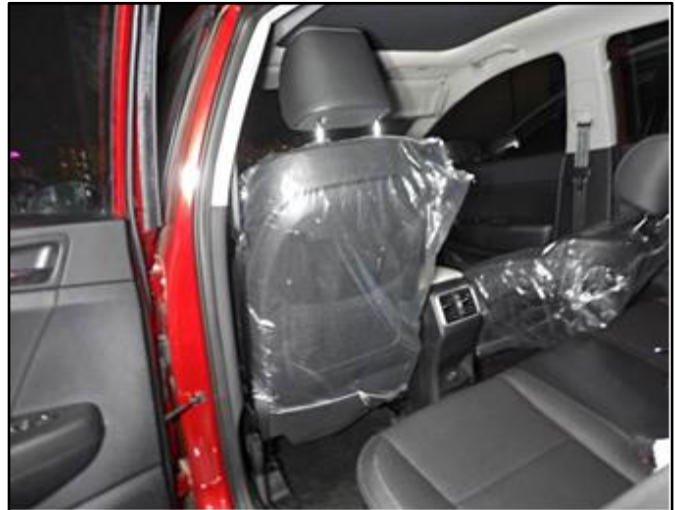
1. Move seat full forward.
2. Check the position of the side air bag harness and front seat back board strap below the front seat.
