GROUP ELE	MODEL 2014-2016MY Sportage (SL), Cadenza (VG) 2014MY Optima (QF/TF/TF HEV)
	NUMBER 117	DATE October 2016

TECHNICAL SERVICE BULLETIN

SUBJECT: NAVIGATION SOFTWARE UPDATE - NO SIRIUS TRAFFIC DISPLAY

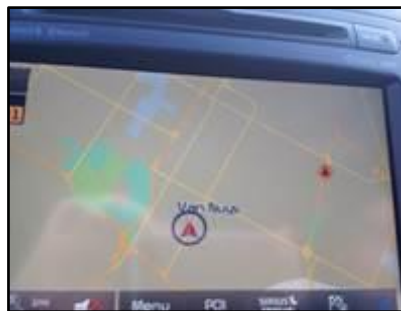
This bulletin provides the procedure for updating the Navigation software on some Sportage (SL), Cadenza (VG), Optima (QF/TF), and Optima (TF HEV) vehicles, which may experience an inactive (grayed out) Sirius Traffic icon, no traffic flow shown, or a "There is no traffic on route." message. Follow the procedure outlined in this bulletin to improve the Navigation system logic.

No Traffic Flow Shown

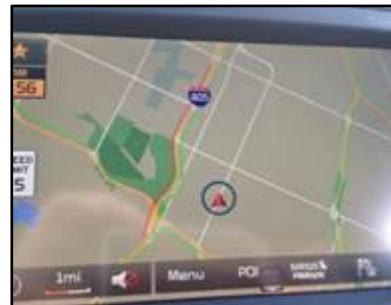
Traffic Flow That Should Show Same Location
