GROUP ENG	MODEL 2012~2015MY Optima (QF) 2012~2015MY Sorento (XMa) 2011~2015MY Optima (TF) 2014~2016MY Sportage (SL) w/2.4 GDI Engine
	NUMBER 160	DATE October 2016
TECHNICAL SERVICE BULLETIN		
SUBJECT: ECU UPGRADE – MIL ON WITH DTC(s) P0420/P0171

P0420: Catalyst System Efficiency below Threshold (Bank 1)
P0171: System Too Lean (Bank 1)

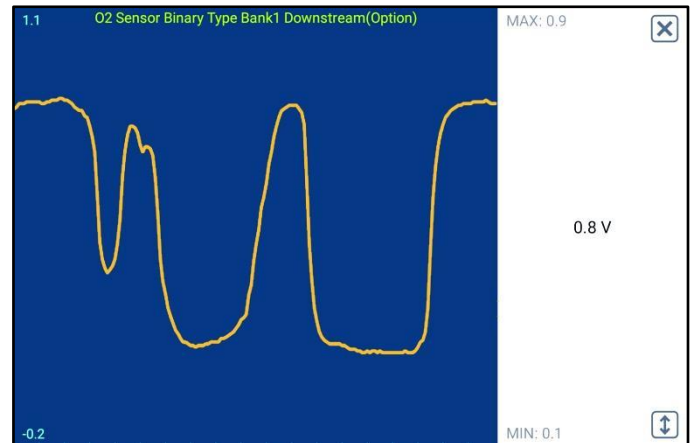
3. If the O₂ sensor signals are abnormal or erratic, as shown, proceed to the Service Procedure on Page 3. **NOTE: After exhaust manifold replacement, proceed to ECU upgrade on Page 4.**
