GROUP	MODEL
ELE	2017MY
	Sorento (UMa)
NUMBER	DATE
116 (Rev 1, 10/04/2016)	September 2016

TECHNICAL SERVICE BULLETIN

SUBJECT: SERVICE ACTION: LANE DEPARTURE WARNING

SYSTEM DTC C180508 (SA243)

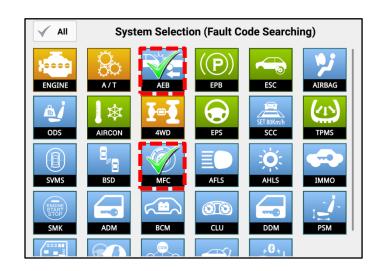
Scan for DTC C180508 in the AEB and MFC using a GDS/KDS.

- If DTC <u>is active</u> or in history, proceed to step 2 below <u>and</u> perform the Calibration Procedure on page 4.
- If DTC <u>is NOT active</u> or in history, proceed to step 2 below.
