MODEL
Optima (QF/TF) All
Optima Hybrid (TF HEV) All

NUMBER
PS343

DATE
August 2014

SUBJECT: OILY SUBSTANCE DRIPPING FROM MDPS
STEERING COLUMN

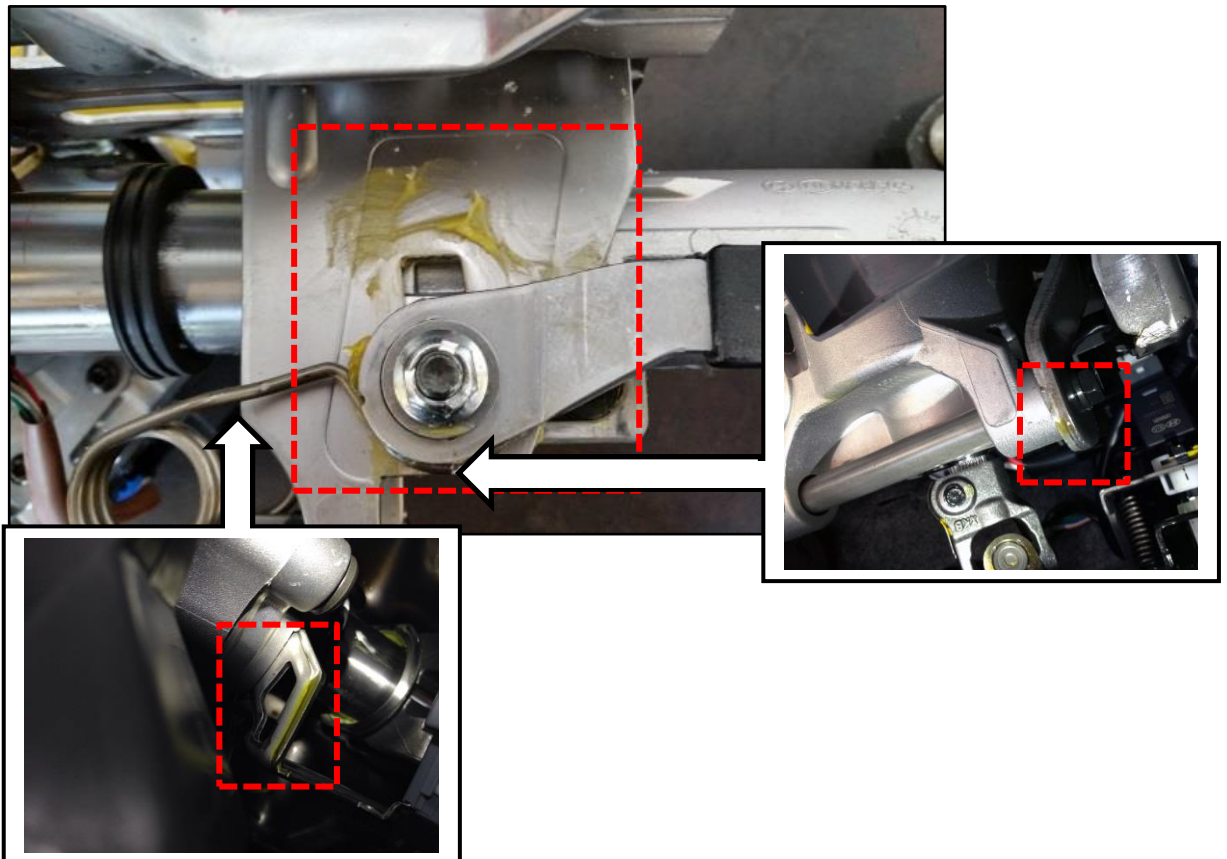
On some Optima (QF/TF/TF HEV) vehicles, the customer may complain of an oily substance dripping onto the driver's side floorboard area, especially in areas with high ambient temperatures. This concern may be due to an excessive amount of grease applied to the steering column tilt adjustment area, which may become liquefied and drip when heated past its melting point. Using a clean shop towel, remove the excess layer of grease from around the column pivot area, being sure to leave sufficient grease to allow for easy adjustment of the tilt mechanism. Do NOT replace the MDPS steering column to resolve this concern.
