MODEL  
2016MY  
Optima (JFa)  
Sorento (UMa),  
w/2.4L GDI

NUMBER  
158 (Rev 2, 11/18/2016)

## TECHNICAL SERVICE BULLETIN

SUBJECT: VCM LOGIC IMPROVEMENT - DTC P200A00 (SA240A)

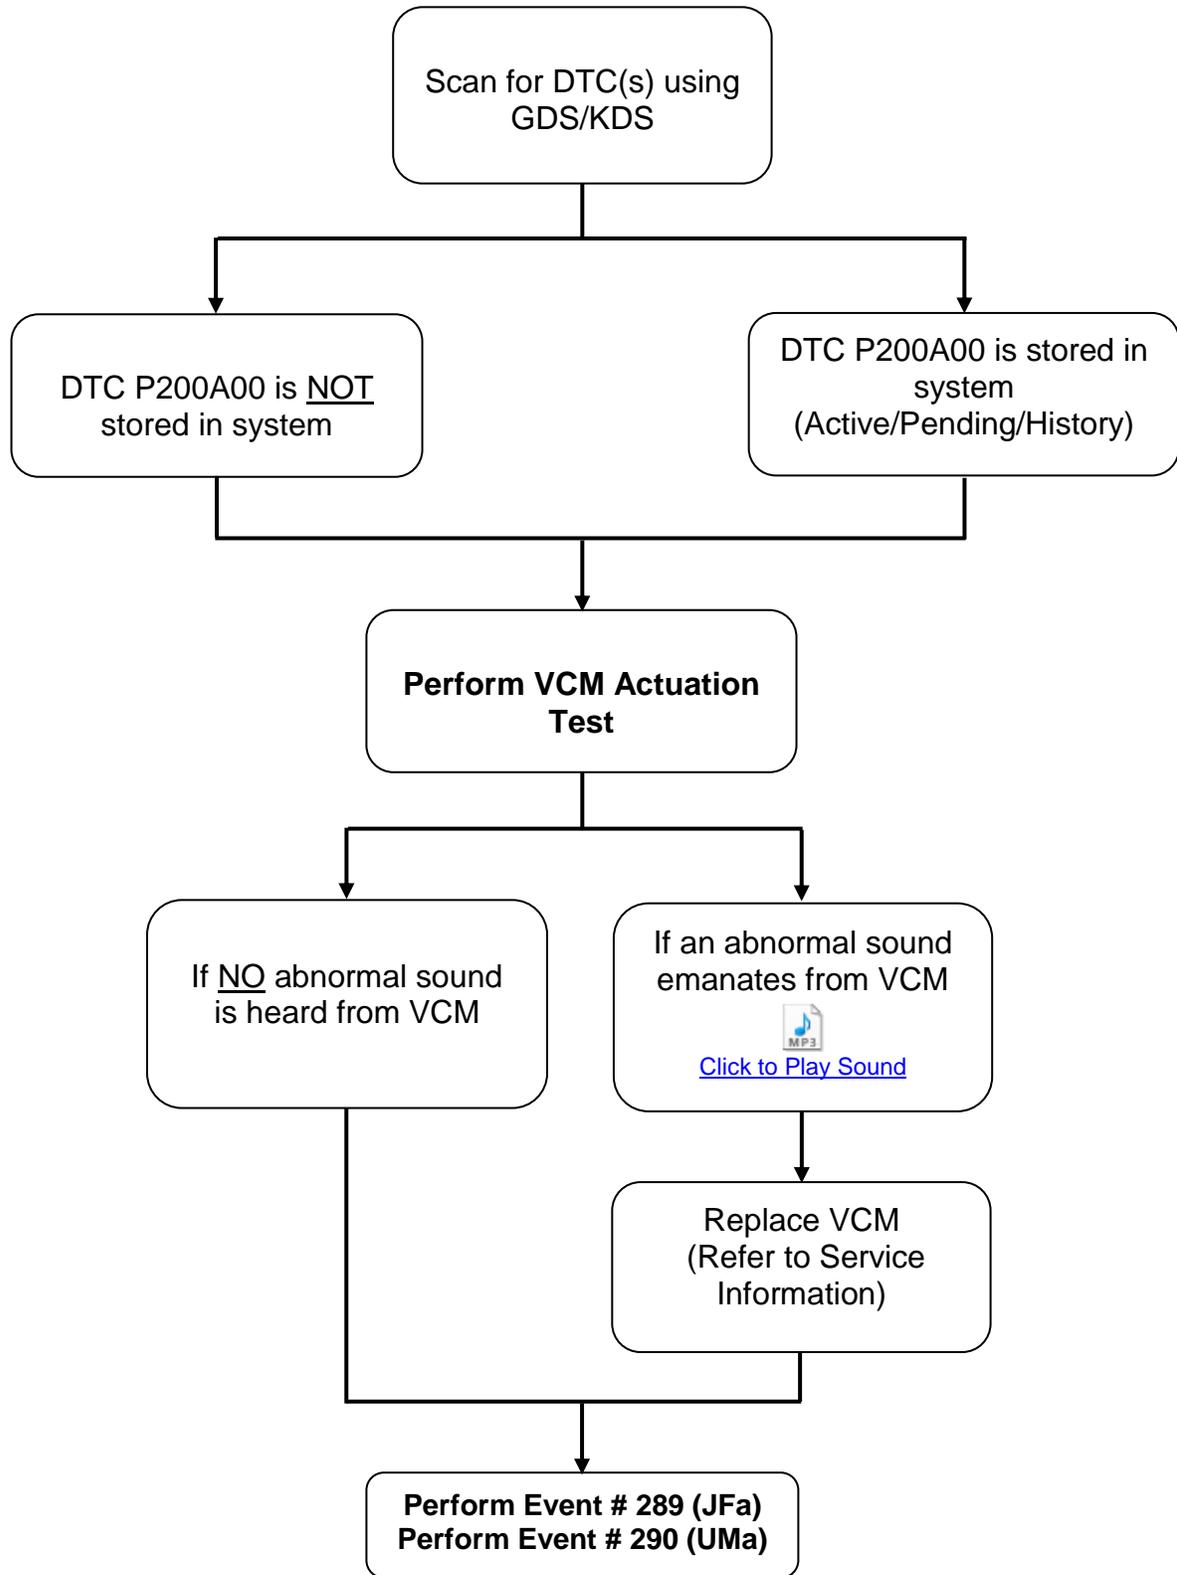
**Diagnostic Flowchart:**

### DTC P200A00 - Intake Manifold Runner Performance

**Do not replace the intake manifold for this concern. Any associated claims for intake manifold replacement are subject to review and chargeback.**
