GROUP ENG	MODEL 2012~2015MY Optima (QF) 2012~2015MY Sorento (XMa) 2011~2015MY Optima (TF) 2014~2016MY Sportage (SL) w/2.4 GDI Engine
	NUMBER 160 (Rev 1, 11/15/2016)	DATE October 2016

TECHNICAL SERVICE BULLETIN

SUBJECT: ECU UPGRADE – MIL ON WITH DTC(s) P0420/P0171

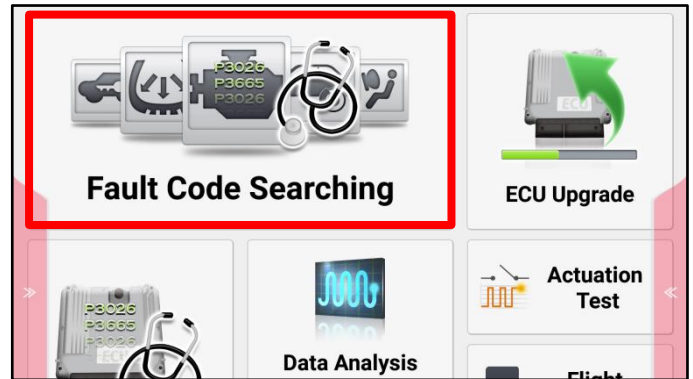
1. Scan and confirm DTC P0420 with possible DTC P0171 using GDS/KDS.

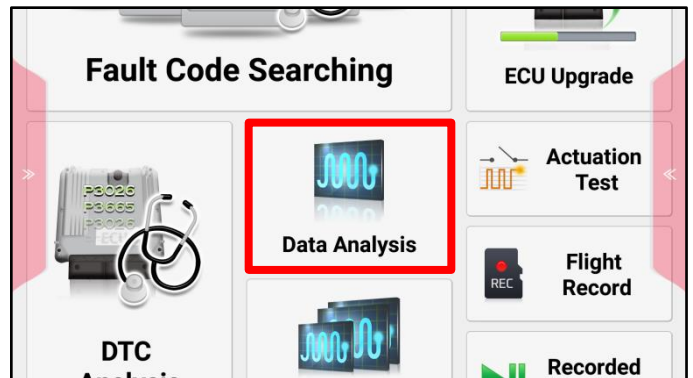
2. After the vehicle has reached normal operating temperature, with the engine at idle, access **Data Analysis** and view the downstream O₂ sensor signals.

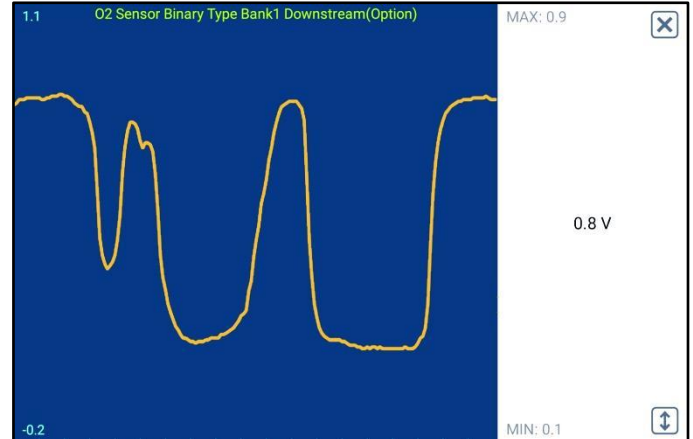
3. If the O₂ sensor signals are abnormal or erratic, as shown, proceed to the Service Procedure on Page 3. **NOTE: After exhaust manifold replacement, proceed to ECU upgrade on Page 4.**

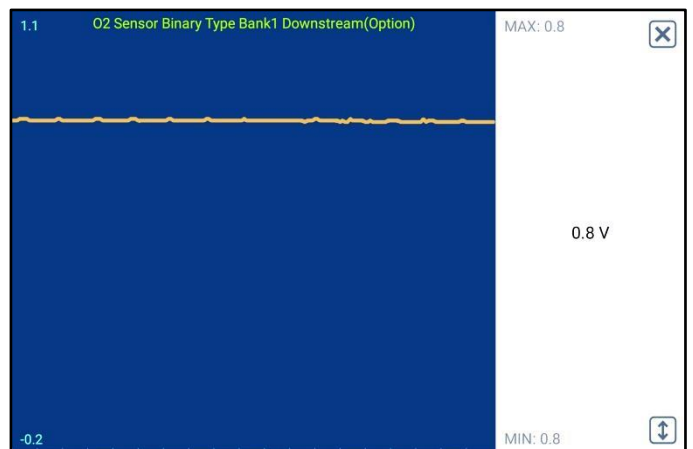
4. If the O₂ sensor signals are normal, as shown, proceed to the ECU Upgrade Procedure on Page 4.

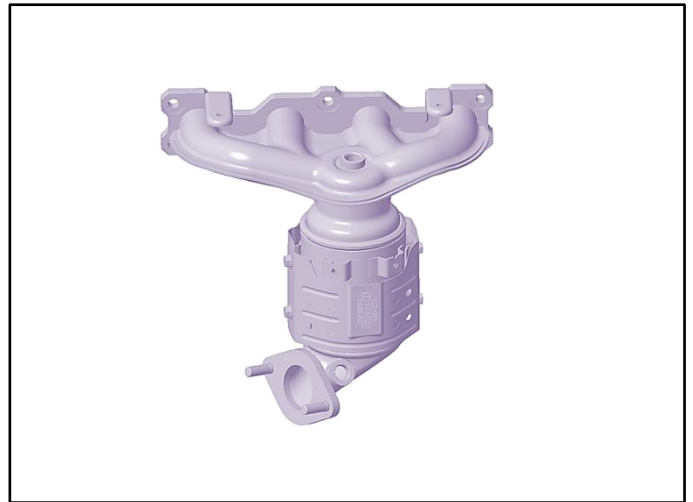
Before installing the new exhaust manifold, see step 2 below and inspect the under-floor catalytic converter for debris.

1. Refer to the “Exhaust Manifold → Removal” section in the applicable Workshop Manual on KGIS, to replace the exhaust manifold.

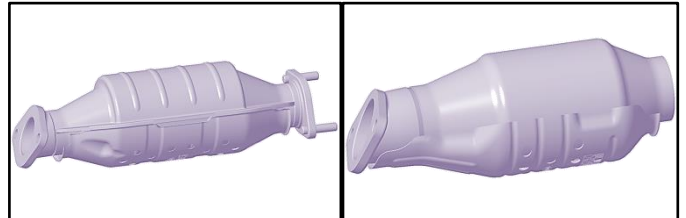
2. With exhaust manifold removed, inspect the under-floor catalytic converter.

If debris in the under-floor catalytic converter is excessive and cannot be removed, replacement of the under-floor catalytic converter is necessary to ensure proper operation of the catalytic converter.

If debris in the under-floor catalytic converter is minimal, remove debris and proceed to the ECU Upgrade Procedure on page 4.
