MODEL
2014MY
Sorento (XMa)

NUMBER
035

TECHNICAL SERVICE BULLETIN

V6 FUEL INJECTOR REPLACEMENT

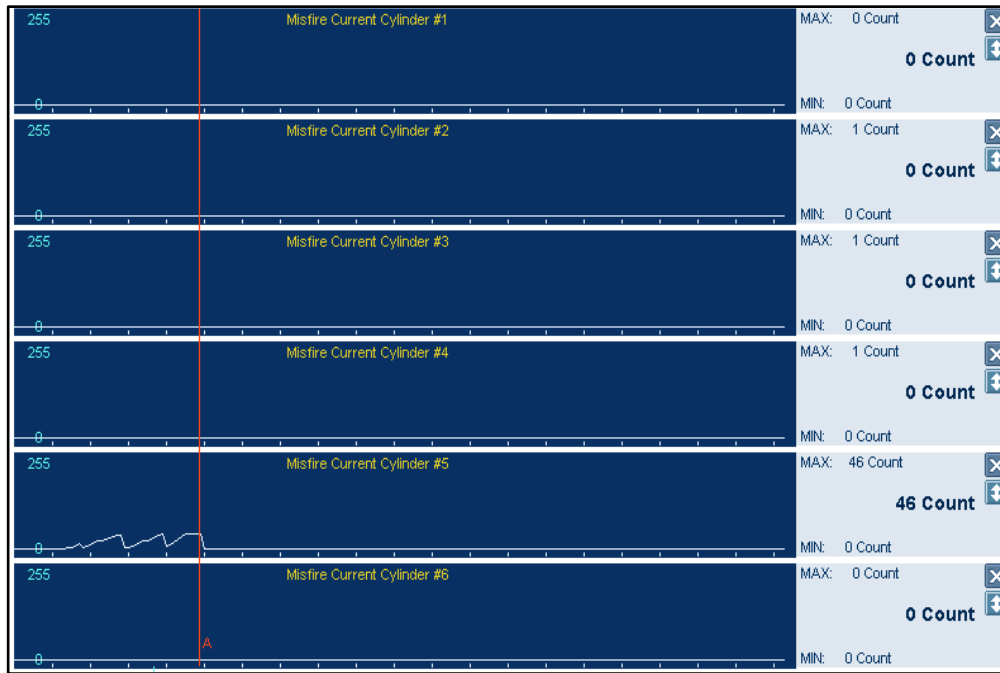
The example below shows a rough idle condition on cold start due to the injector in Cylinder #5.

1. Replace all the fuel injectors by referring to the “Engine Control/Fuel System → Engine Control System → Injector → Repair procedures” chapter in the applicable workshop manual on KGIS.
2. Start the engine again after an overnight cold soak to ensure successful correction of the concern.
