MODEL  
2016MY  
Optima (JF)

NUMBER  
060 (Rev 1, 11/15/2016)

## TECHNICAL SERVICE BULLETIN

SERVICE ACTION: AXLE DRIVESHAFT  
REPLACEMENT (SA241)

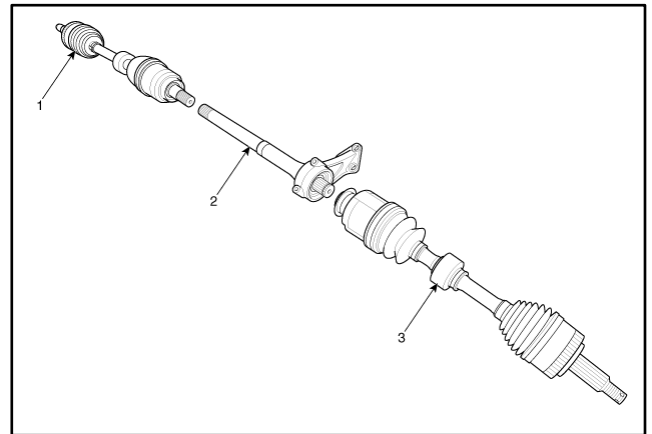
This bulletin provides information on some 2016MY Optima (JF) vehicles, produced in South Korea from March 24, 2016 to April 8, 2016, which may exhibit a noise originating from the axle driveshaft during acceleration. To correct this concern, replace the left and right front axle driveshafts by following the procedure outlined in this bulletin. Before conducting the procedure, verify that the vehicle is included in the list of affected VINs.

1. Replace both left and right front axle driveshafts by referring to the “Driveshaft and axle → Driveshaft Assembly → Front Driveshaft → Repair procedures” chapter in the applicable Workshop Manual on KGIS.

Do not re-use the castle nuts during re-assembly. Always replace with new parts to maintain the proper locking feature of the design. Failing to do so may result in unintended loosening and/or loss of the fasteners, which in turn could lead to the loss of an assembly's integrity.
