GROUP TRA	MODEL ≥ 2011MY
	NUMBER 055	DATE October 2014
TECHNICAL SERVICE BULLETIN		
SUBJECT: INHIBITOR SWITCH DIAGNOSIS INFORMATION

SUBJECT: INHIBITOR SWITCH DIAGNOSIS INFORMATION

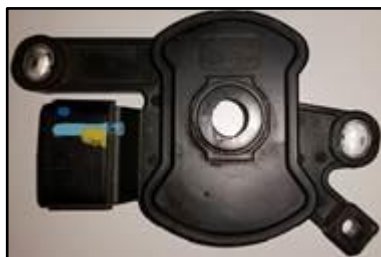
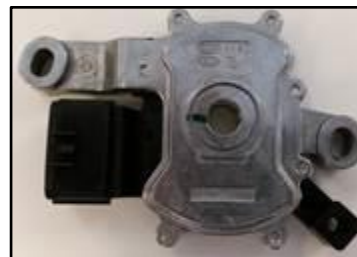
In some cases, part numbers will supersede and the replacement inhibitor switch may appear different from the part being replaced, as shown below. Refer to EPC for correct application and part number.

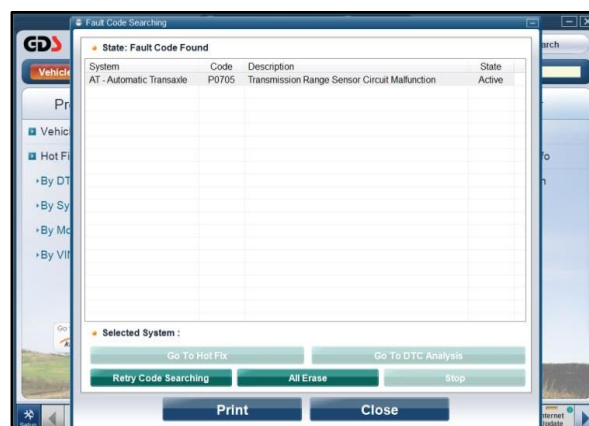
1. Connect GDS to the vehicle and perform a self-diagnosis.

- If no DTC(s) are found, proceed to step 2.
- If DTC P0705 or any other DTC(s) are found, delete the DTC and proceed to step 2.

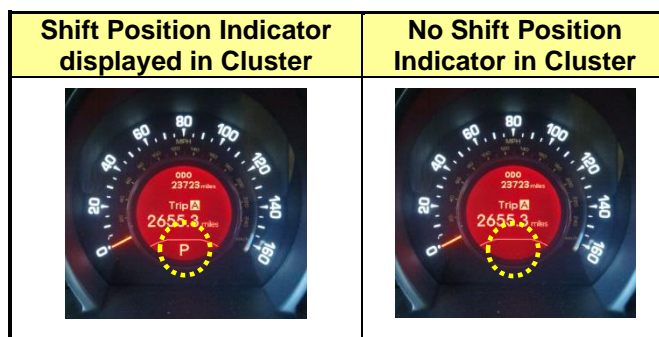
2. Place the shifter in Park ("P") and Neutral ('N') position and visually inspect the shift lever position indicator in the cluster.

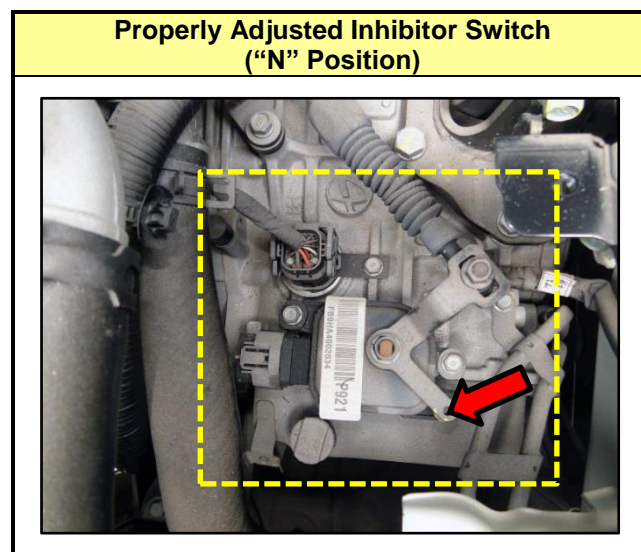
3. Place the shifter in Neutral ("N") and visually inspect the Inhibitor Switch for proper adjustment.

- If while in "N" position the inhibitor switch is properly adjusted, proceed to step 4.
- If while in "N" position the Inhibitor Switch is out of adjustment, refer to "Automatic Transaxle System > Automatic Transaxle Control System > Inhibitor Switch" chapter, in the applicable Workshop Manual, to adjust the Inhibitor Switch. Make sure to use the Inhibitor Switch Guide Pin (SST P/N 09480 A3800) while performing the Inhibitor switch adjustment procedure.
- If after adjusting the Inhibitor Switch the condition persists, proceed to step 5.

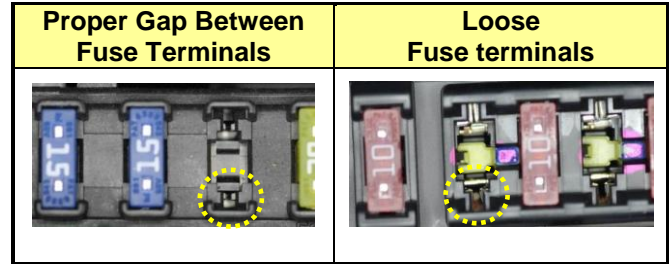
SUBJECT:**INHIBITOR SWITCH DIAGNOSIS INFORMATION****4. Inhibitor Switch Connector and Fuse Block Inspection Items**

- Check the connector for foreign matter intrusion.
- Check the Fuse Block for loose fuse terminals.

Correct or repair as required.

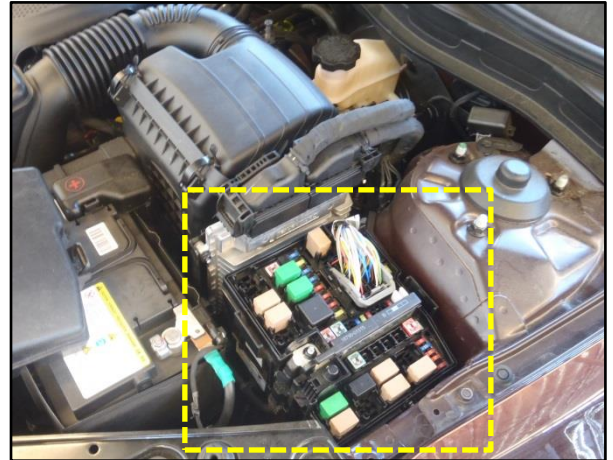
**5. Locate the Junction Box in the engine compartment and check the TCU2 fuse and the Inhibitor Switch connector.****Inspect the following items:**

- Check the fuse capacity
- Check for a burned-out fuse
- Check the fuse holder
- Check for pinched wires, foreign matter intrusion and for bent pins in the connector.

Correct or repair as required.

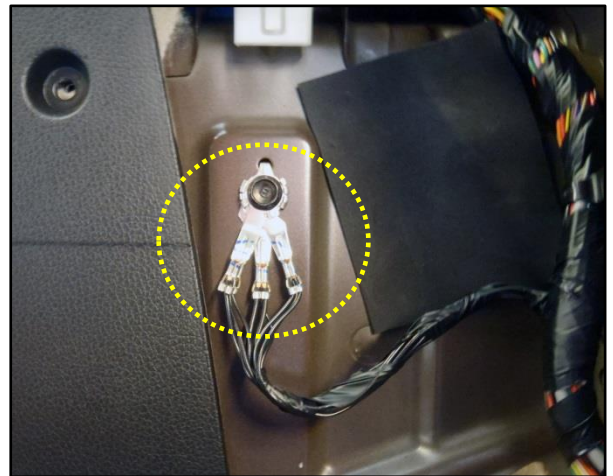
**6. Check the rear combination lamp harness for a proper ground.****NOTE:**

If the rear combination lamp is properly grounded, replace the inhibitor switch. If not, check/clean ground and tighten the bolt.
