Technical Journal

Air vents, blisters/bubbles

REF NO: TJ 19967	ISSUING DEPARTMENT: Technical Service	CAR MARKET: United States and Canada			
3 US 7	PARTNER: '510 Volvo Car USA	ISSUE DATE: 2016-05-26	STATUS DATE: 2016-06-03		
FUNC GROUP: 8819	FUNC DESC: Miscellaneous	Page	1 of 3

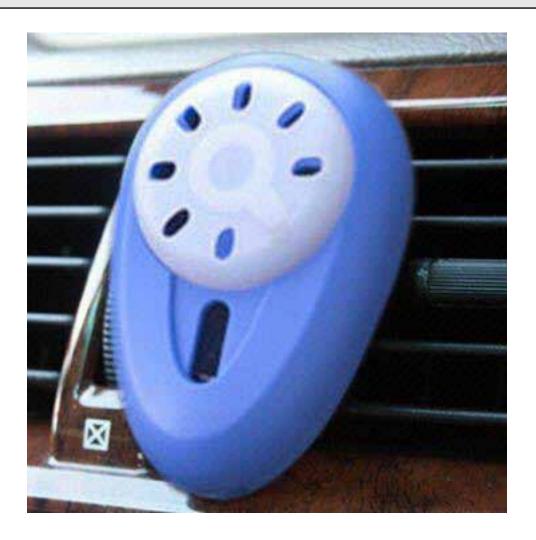
Blisters/bubbles may appear on the air vent surfaces (see picture "Damaged surface. jpg"), follow instructions under Service.

^{*} Do not attach any sort of air freshener directly on air vents.

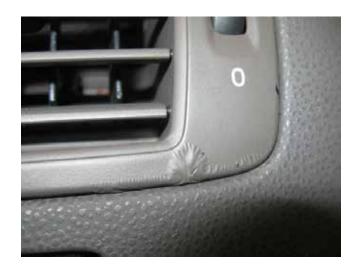
The blistering of the material is often caused by an air freshener applied directly to the air vents, see picture ("Air freshener1.jpg").
