Technical Journal

Noise front wheel hub and/or DTC in BCM

REF NO: TJ 25329	ISSUING DEPARTMENT: Technical Service	CAR MARKET: United States and Canada		
PARTNER: 3 US 7510 Volvo Cars North America		ISSUE DATE:		
FUNC GROUP: 7731	FUNC DESC: Hub, front	YEAR 2016	MONTH 06	DAY 15
Page 1 of 5

Volvo Car Customer Service	
	TJ Instruction
	TJ No. 25329
	Date July-2014 Issue 00
Title	Scraping noise, Front wheel hub conflict with brake disk, BCM-C003307 C003007

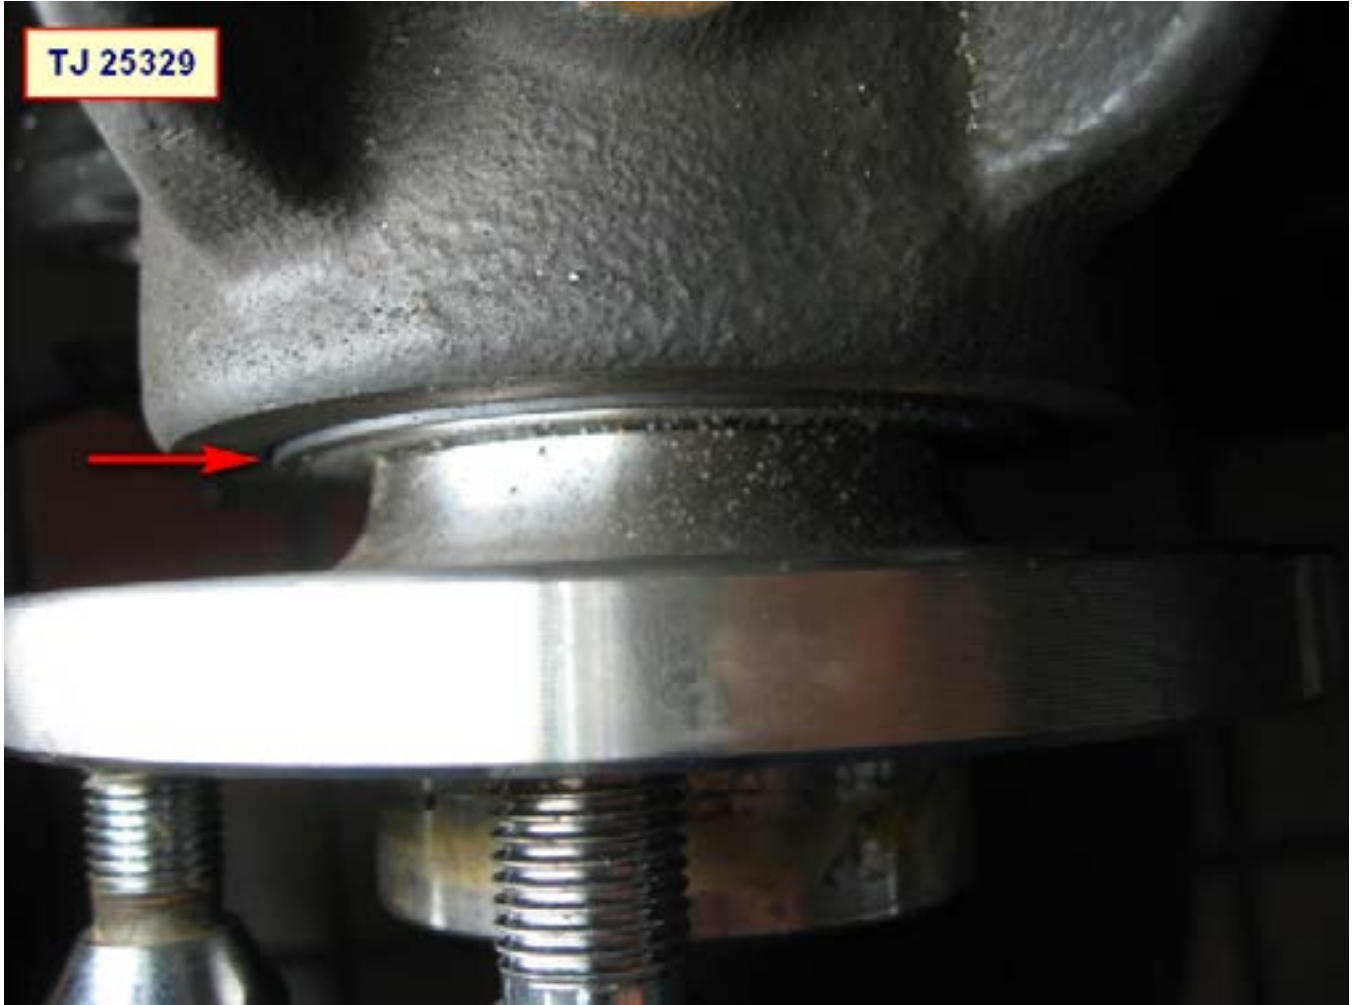
TJ 25329

Check if the wheel hub is displaced in the steering knuckle, refer to picture "[TJ 25329 -1.jpg](#)". If found replace the wheel hub according to VIDA.

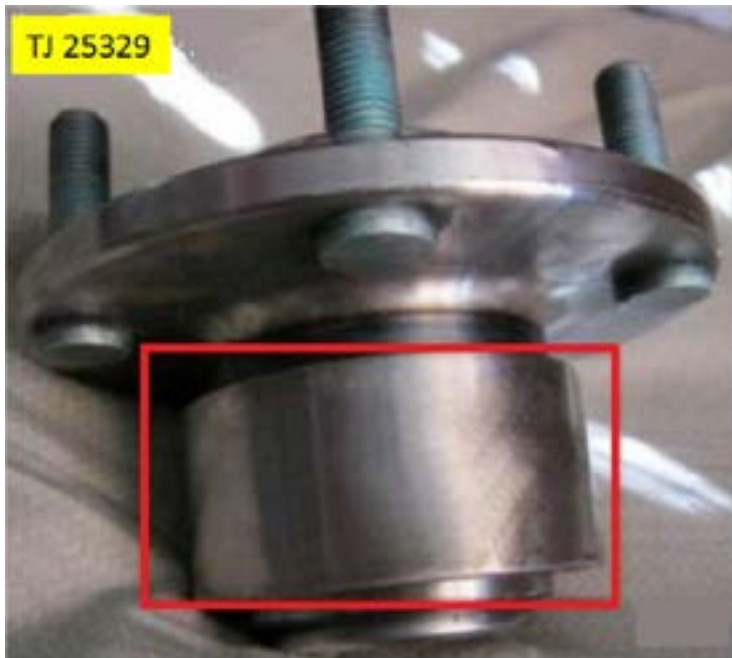
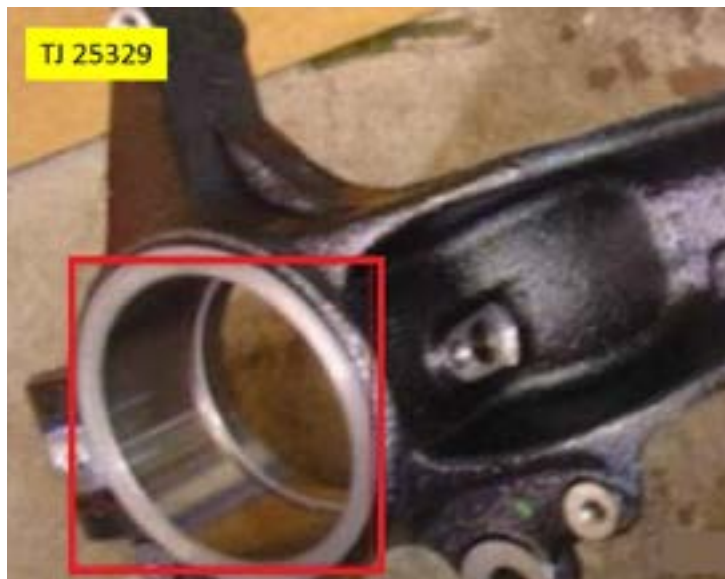
Surfaces to be cleaned using Volvo Cleaner, PN 1161721:

Note: Clean the new wheel hub and existing steering knuckle according to [TJ Attachment 25329.pdf](#).
