Technical Journal

Deco panel front doors, difficult to mount

REF NO:
TJ 31611

FUNC DESC:
Door upholstery

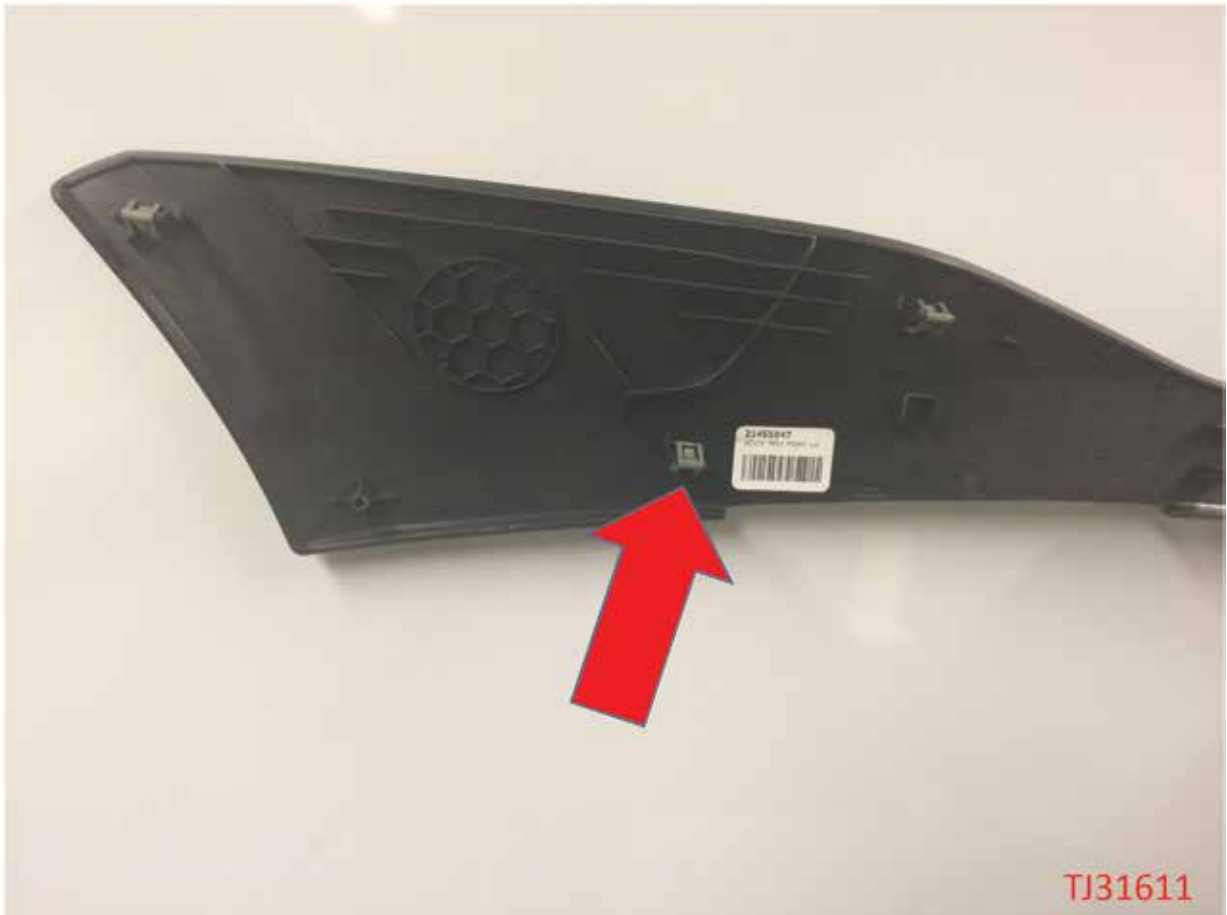
If a front door deco panel is replaced, it may be hard to mount the new one on the door panel.

If the steel clips on the new deco panel are black, remove the steel clip pointed out in picture "TJ31611.pdf". It will sit tight with the remaining clips. The hole will be adjusted in production to align better with the clip. (The metal colored, old type of clips has less precision and therefore fits in the hole.)
