# Front door non-laminated glass, rattling noise in down position

REF NO: TJ 30762.2.0			CAR MARKET: United States and Canada	
3 US 7	PARTNER: 7510 Volvo Car USA	ISSUE DATE: 2016-07-18	STATUS DATE: 2016-07-22	
FUNC GROUP:  8455  Guide moulding for door glass; sealing		Page <sup>-</sup>	1 of 10

# Volvo Car Customer Service TJ 30762

Title	Window, front door.	Page	1 (7)
Action	Adjustment	Operation number:	98616-2

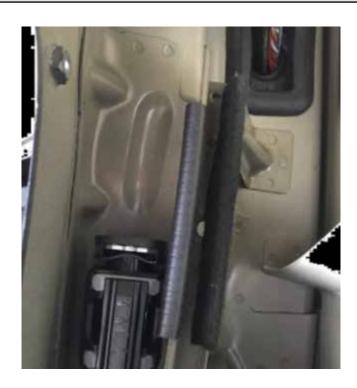
A rattling noise may occur while closing the front door with the window in down position. Only vehicles with non-laminated glass can be affected.

Add a felt tape P/N 30788314 (max 2 mm thickness) on the front door glass run channel according to attached service instruction.
