VOLVO CAR SERVICE AND PARTS BUSINESS

# **Technical Journal**

### TITLE: Oil leakage from plug in Variable Valve Timing pulley

REF NO:	ISSUING DEPARTMENT:		ARKET:
TJ 29131.3.0	Technical Service		s and Canada
3 US 7	PARTNER:	ISSUE DATE:	STATUS DATE:
	7510 Volvo Car USA	2016-08-08	2016-08-09
FUNC GROUP: 2150	FUNC DESC: Transmission	Page	1 of 9

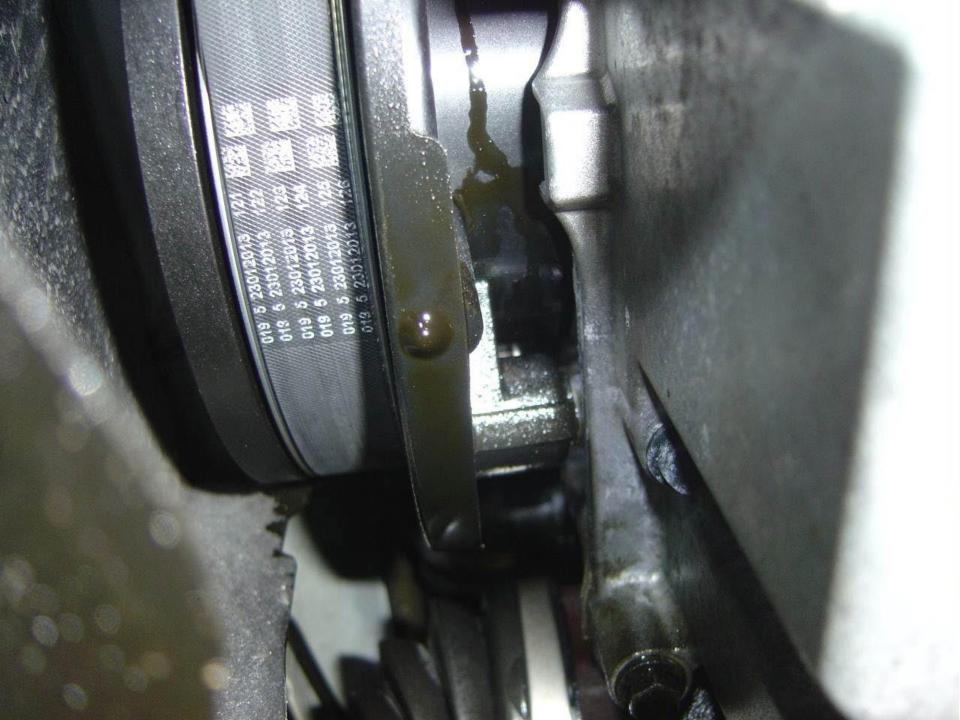
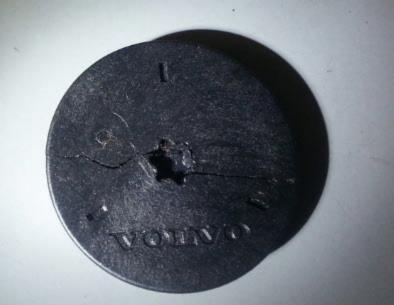
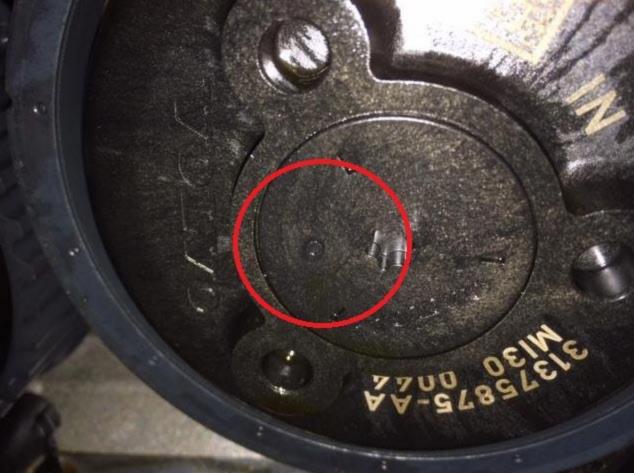
Customer may experience a low oil level warning in DIM and /or oil leakage from the engine. The oil may leak due to a crack in the plug from the VVT pulley (see attached photo).

Replace both plugs in both VVT-pulleys according to the attached instruction. Plug PN:31375877 If the timing belt is effected with oil, replace the timing belt according to VIDA instructions.
