TITLE:							
Rear door, water intrusion							
REF NO:	ISSUING DEPARTMENT:	CAR MARKET:					
TJ 31542	Technical Service	United States and Canada					
	PARTNER:	ISSUE DATE:	STATUS DATE:				
3 US 7	7510 Volvo Car USA	2016-05-13	2016-05-17				
FUNC GROUP:	FUNC DESC:						
8400	Outside trim parts, glass, sealing mould	Page 1 of 7

VOLVO	olvo Car Customer Service	TJ 31	1542
Title	Weatherstrip, door window, rear	Page	1 (5)
Action	Adjustment	Operation number:	98630-2

Model year	Model	
2016	XC90	(16-)

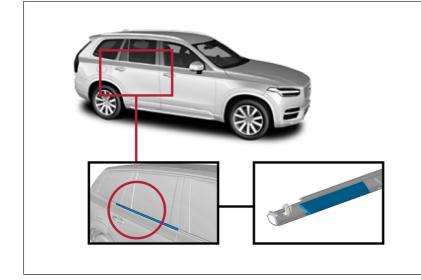
Water may accumulate on the rear door sill. Water may come out of the lower edge of the rear doors when opening the rear doors.

TJ 31542	Page 3 (5)
Removal	
	Caution! Make sure that the component is not bent. Remove the marked part. On both sides.
Installation	
	Make sure to replace the marked component with a new.
31402039 X2
