## CCV Housing Inlet Tube, Replacement D11J VAH, VHD, VN

### FSB 257-004, CCV Housing Inlet Tube, Replacement

(June 2016)

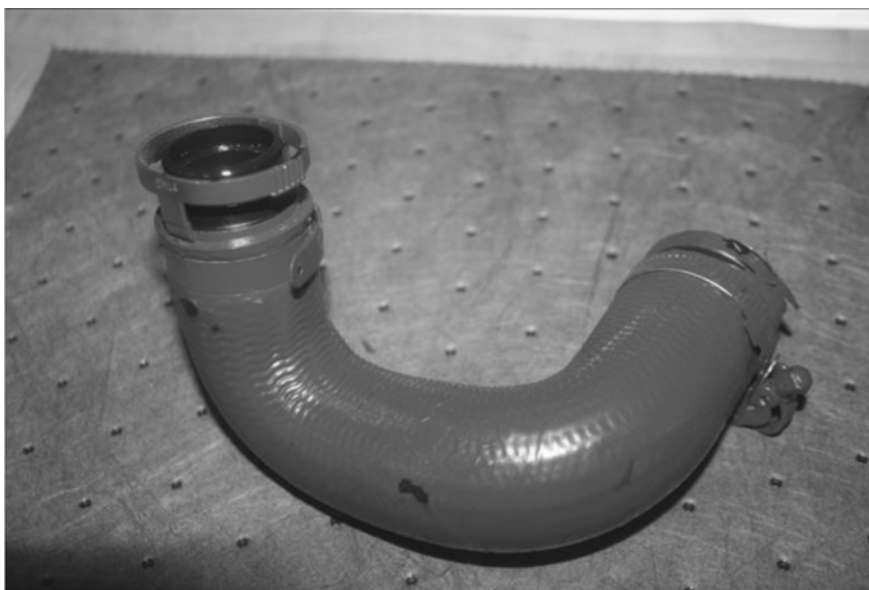
W2111722

VOLVO Trucks has received reports from the aftermarket regarding oil leaks at the CCV housing inlet tube and at the split line between the upper and lower housings on chassis builds between January 1, 2014 and January 26, 2016 with D11 engines. It has been determined that the O-ring installed on the inlet tube is the source of the leak and oil may leak down the back of the housing giving the impression that the housing split line is also leaking.

Should there be a report of this nature on a chassis built within the affected date range, do not disassemble the CCV. Replace the inlet tube with part number 22858729. Clean the surrounding area to complete the repair. If it is determined that there is a leak at the housing other than the inlet O-ring, the complete CCV assembly will need to be replaced as this is a non-serviceable part. Do not attempt to tighten the split line screws on the housing or disassemble the assembly as seals and repair parts are no longer available for this component as they were on the older version of this component. If the collar on the CCV inlet is worn or broken at the locking lip, replace the complete CCV assembly.
