I-Shift Transmission With Mixed Components
 Version-C
 AT2512C, ATO2512C, and ATO3112C
 VN, VHD, VT

FSB 431-001, I-Shift Transmission With Mixed Components

(November 2010)

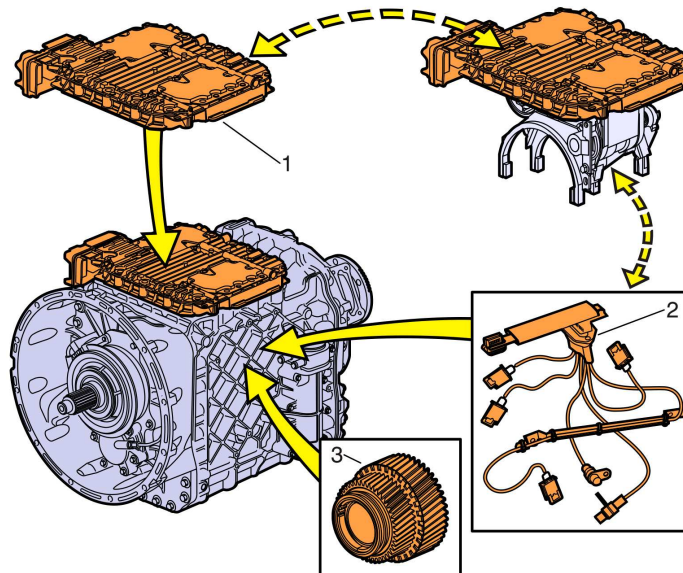
As of June, 2009 the new generation I-Shift transmission (Generation D) was released for production. There are three parts used in combination with the generation D (New) or C (Old) versions of the I-Shift transmissions (see figure below).

- 1 Transmission Electronic Control Unit (TECU).
TECU-D (New generation) or TECU-C (Old generation)
- 2 Cable harness including speed sensor.
Speed-sensor-D (New generation) or Speed-sensor-C (Old generation)
- 3 Sensor wheel.
72 tooth (New Generation) or 30 tooth (Old Generation)

Note: The difference between the new generation Gear Control Unit (GCU-D) assembly and the old generation Gear Control Unit (GCU-C) assembly is the TECU-D (1) and the new speed-sensor-D (2). The rest of the GCU is equivalent to the old generation.

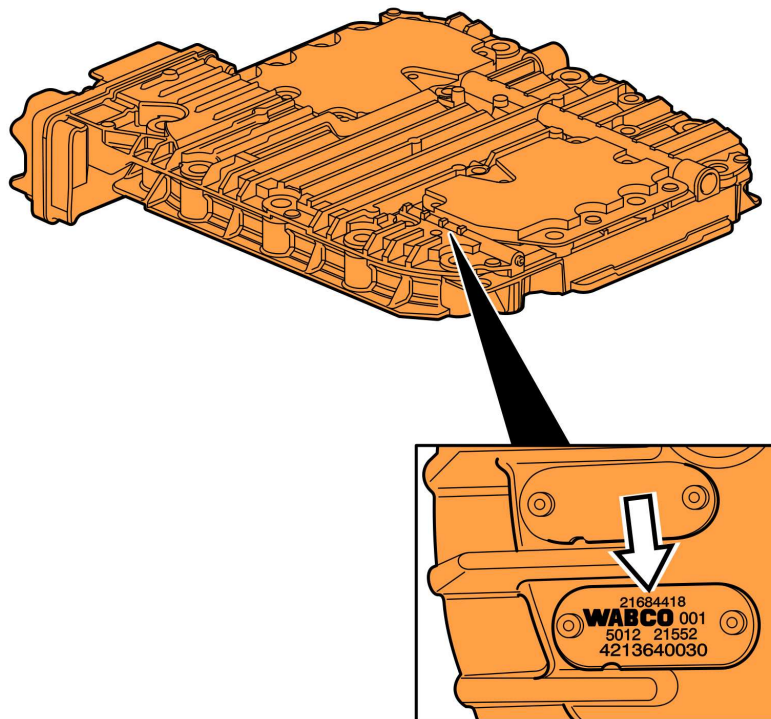
W4116719

When installing a replacement part TECU-D or complete GCU-D assembly in an I-Shift generation C transmission, a conversion kit must be run. Follow with download of software to MID130, enabling the TECU-D to identify if it is installed in an I-Shift generation C transmission. To select the correct conversion kit, TPI 432-014 and TPI 432-015 have been released. Both are connected to the related part numbers in Impact. The conversion kit will add parameters KBQ and KBR to the TECU-D. By setting these in different combinations the software will identify if either a TECU-D or complete GCU-D is installed in an I-Shift generation C transmission. If the correct conversion kit is not run, a DTC MID130 PID160 FMI1 or FMI2 will result.

TECU Version and Hardware			
TECU Version	Emission Level	Hardware Part Number	Reman Part Number
TECU-C	US07	20829012	N/A
TECU-D	US07 & US10	21274018	N/A
TECU-D	US07 & US10 & OBD13	21484418	85013226

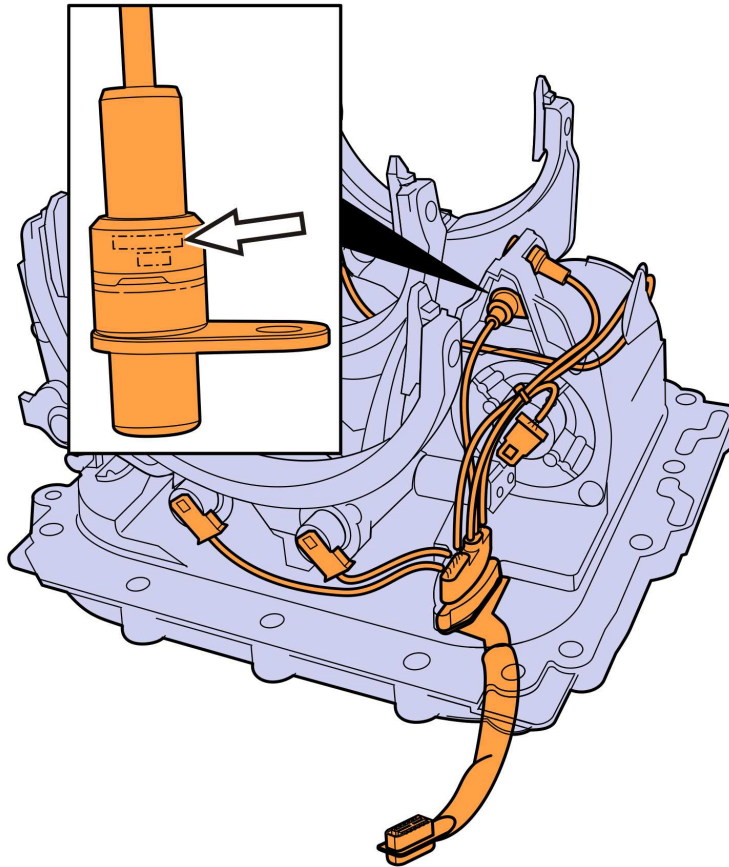
W4059595

The new cable harness includes a new speed-sensor. The cable harnesses are not marked with different part numbers. To identify the speed sensor generation, look at the number stamped on the sensor.

Note: To identify speed sensor with cable harness, see graphic below for details.

Identify Cable Harness With Speed Sensor			
I-Shift Transmission Version	Cable Harness	Speed Sensor Version	Speed Sensor Number
Generation-C	20775027	Generation-C	4410371001
Generation-D	21068284	Generation-D	4410371051

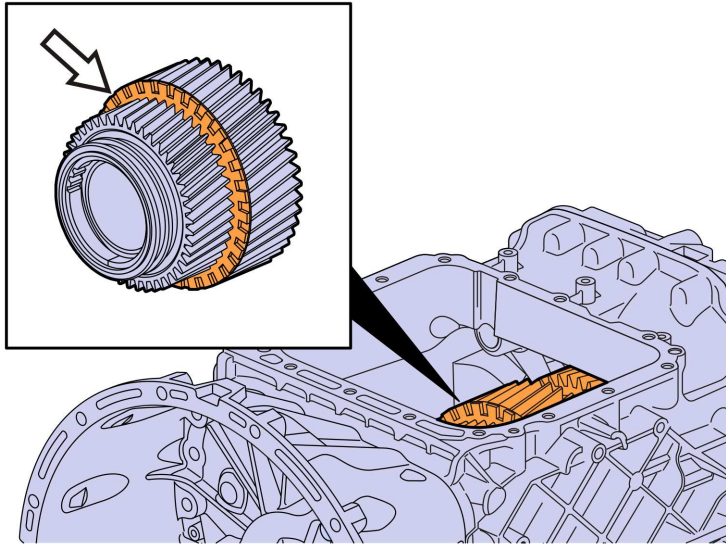
W4059593

For the main shaft there is a new sensor wheel which has 72 tooth compared to the old version which had 30 tooth. The 72 tooth sensor wheel is installed in the I-Shift generation D transmissions and I-Shift generation C transmissions built beginning June, 2009. There will be 72 tooth sensor wheels installed in I-shift generation-C Reman units where a complete GCU-D was installed at remanufacturing.

Sensor Wheel Configuration	
Sensor Wheel Part Number	Sensor Wheel Tooth Number
20542400	30
21034006	72
