## **Technical Service Bulletin**

**Tech Service Bulletin #: TSB16-01**

**Date: 11/30/2016**

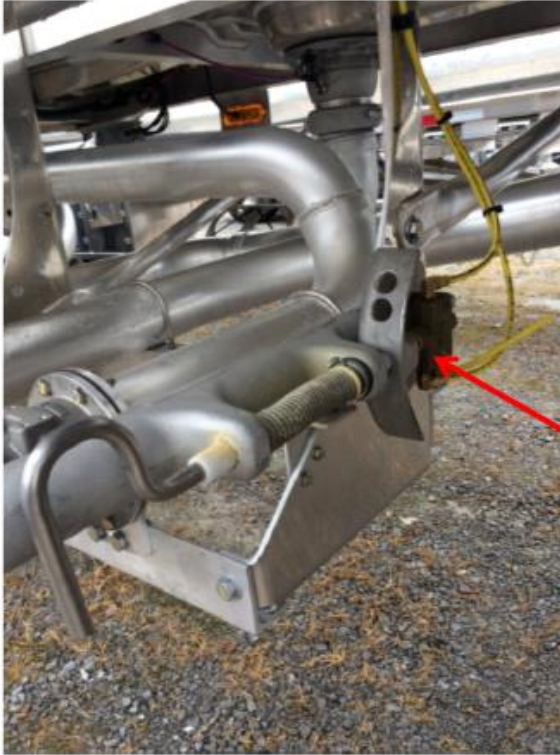
Inspect for loose jam nut on EBW plunger

If you find a loose adjustment screw or set nut on the brake interlock valve at the load bar area, please call 1-800-400-6913 extension 4 for further instructions. If the parts are tight, no actions are required with the exception of responding as mentioned below.

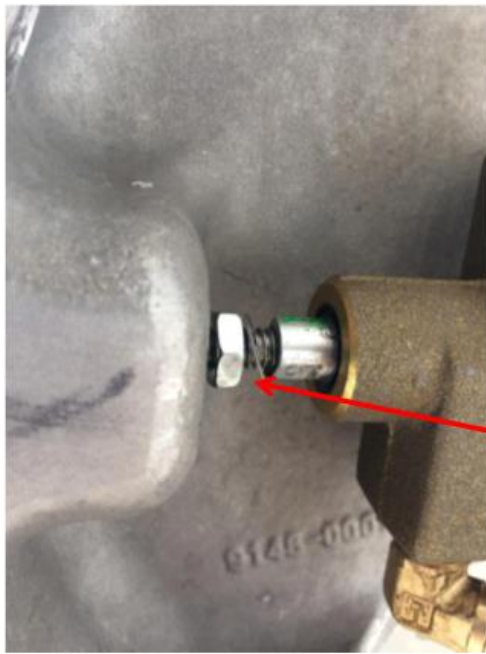
Example of out of adjustment plunger and loose jam nut

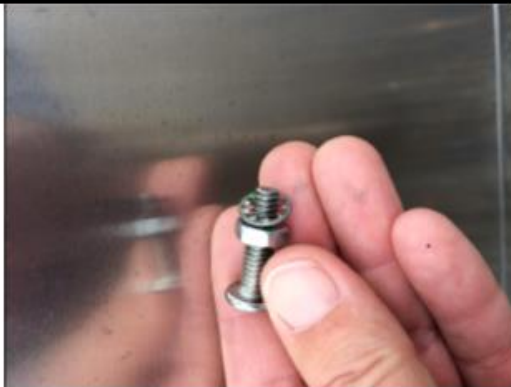
Ensure threads are not damaged and has a star washer between the nut and the EBW plunger.

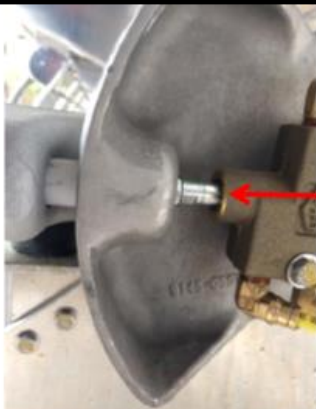
Example of plunger out of adjustment.

- Raise bar interlock
- Back out the screw a few turns from plunger
- Check to make sure plunger is fully depressed by lowering the bar interlock (may require multiple adjustments)
- Once plunger is fully depressed, tighten nut and star washer

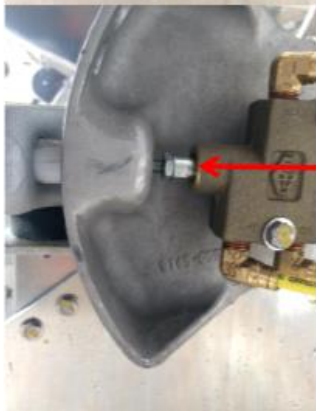
Example of fully depressed plunger when T-Handle is engaged and the bar interlock is lowered.
