Engine Harness Repair
MP7 Engines
CXU, GU, LEU, MRU

FSB 373-022, Engine Harness Repair

(November 2016)

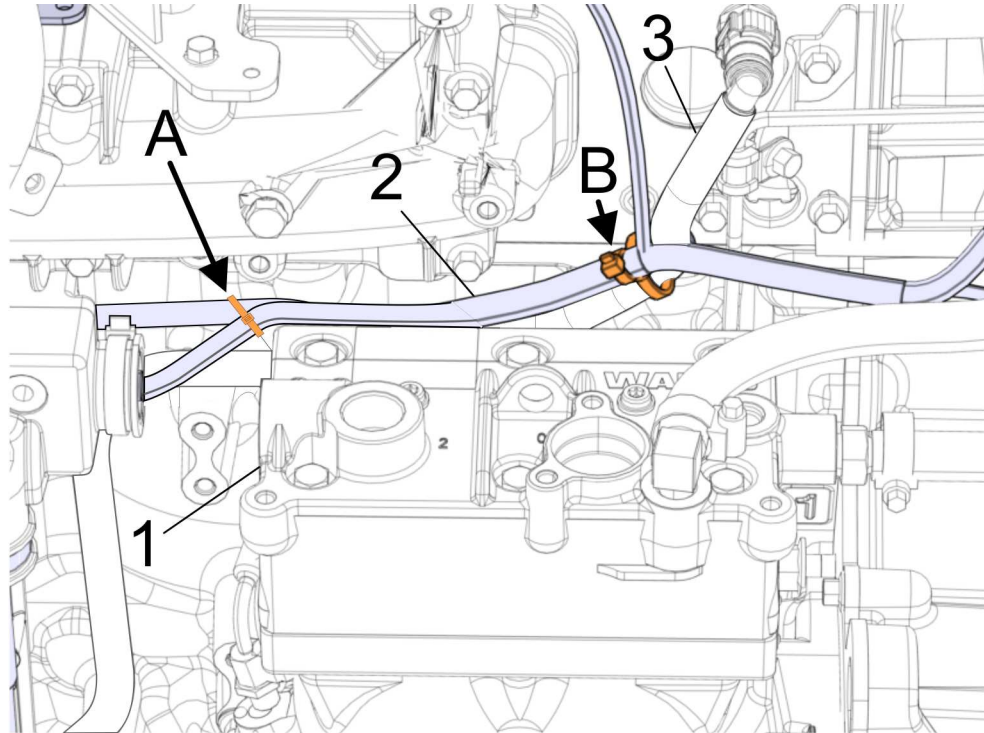
W3116436

The engine harness on MACK MP7 US2015 engines built between March 1, 2015 and September 2, 2016 may be making contact with the air compressor head and rubbing through. When diagnostic trouble codes (DTC) P0201 to P0206 FMI 13 are logging, look in this area first. If this is found to be the root cause of the DTC, it is recommended that the harness be repaired using a splice kit. On reassembly, protect and support the harness in this area.

20 Relocate the engine harness (2) and install double tie retainers (part number 20885496) as shown (B) and single wire tie (part number 948211) to the oil line (A) between the air compressor and the engine block. Ensure harness is not touching air compressor. Make sure the ties are snugged tight.
