# NEWMAR CORPORATION WARRANTY DEPARTMENT

## TECHNICAL SERVICE BULLETIN

DATE ISSUED	MODEL YEAR(S) AFFECTED	TSB #
5/13/2016	2013, 2014	415

**SUBJECT:** IFS Ball Joints

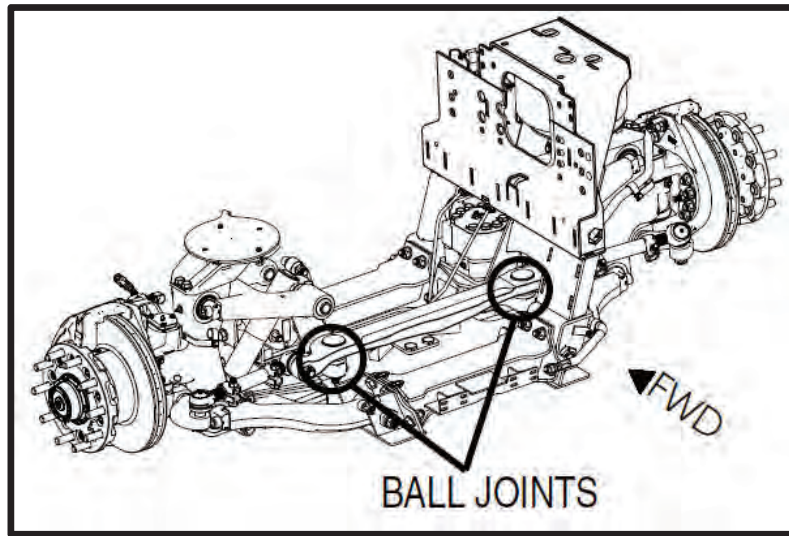
**FIG. 2-1**

1. Follow normal maintenance and safety procedures to gain access to the pitman arm ball joints. Refer to FIG. 2-1.

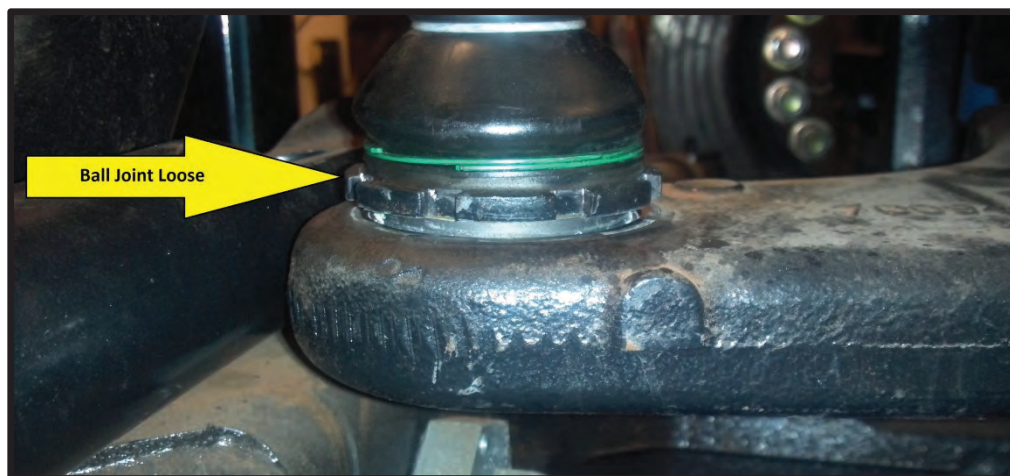
**FIG. 2-2**

2. Visually inspect the ball joints located in pitman arms, the ball joints will be seated in both pitman arms off of the steering gears. The ball joint shall be fully engaged with the notched flange in contact with the surface of the pitman arms. If it is not, please proceed to the repair procedure. Refer to FIG. 2-2 and 3-1 (pictures may not represent suspension you are working on).

3. If the ball joint appears to be seated, using a 0.001 inch feeler gauges to check under the notched flange. If the feeler gauge slides under the flange, please proceed to the step by step instructions.
4. With a punch and hammer use moderate force in an effort to tighten the ball joint in place. If it moves proceed to the step by step instructions. If it is tight this will finish the inspection and vehicle can be returned to service.
