<b>Topic</b>	Bentayga - Battery Energy Control Module 2 software update (ASW 09.03) (SC16/27)
<b>Market area</b>	Bentley: worldwide (2WBE),Hongkong-Macau (5HK)
<b>Brand</b>	Bentley
<b>Transaction No.</b>	2045443/2
<b>Campaign number</b>	EA65
<b>Note</b>	
<b>Type</b>	Service Campaign
<b>US code</b>

Error in software during shut down – module 21 not visible in diagnostic log

Software update to 21 - Battery Energy Control Module 2

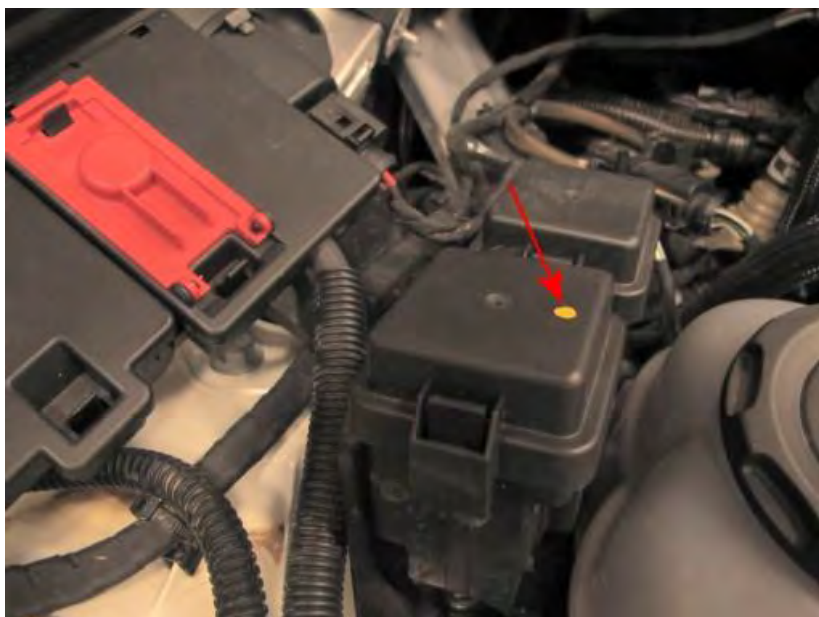
Figure 7

If the vehicle is not already listed as repaired in the "Repair history" (in Elsa Pro), check for the presence of a yellow campaign completion mark on the top of the relay box adjacent to the right hand bonnet hinge (see Figure 7) should neither be evident carry out the required work in accordance with these instructions

19. On completion apply a yellow campaign completion mark to the top of the relay box adjacent to the right hand bonnet hinge (see Figure 7)
