## Technical product information

| <b>Topic</b> | Bentayga tailgate creak |
| <b>Transaction No.</b> | 2045663/1 |

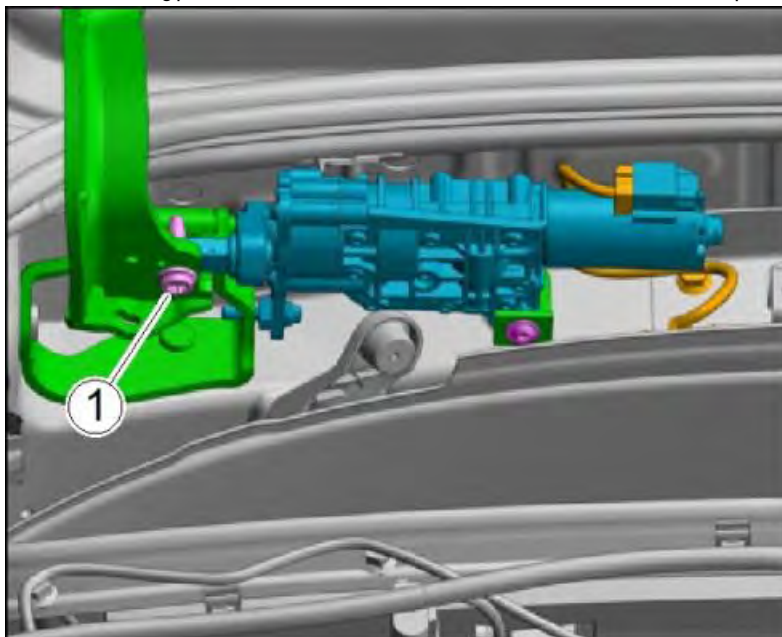
Figure 4

Creak/squeak during tailgate operation

Tailgate drive unit – mechanical link, motor to hinge, torque may relax on fastener

3. With the above roof trim and harness clip removed then fastener -1- can be accessed. Apply a torque of 30Nm to fastener -1-. (see Figure 4)

**Note: The 30Nm is a service torque agreed by Bentley Engineering for the symptom detailed in this TPI, for any other operations on this fastener the workshop manual should be referenced**
