## Technical product information

<b>Topic</b>	Clicking noise from wheel bearing
<b>Market area</b>	Bentley: worldwide (2WBE)
<b>Brand</b>	Bentley
<b>Transaction No.</b>	2027433/2
<b>Level</b>	EH
<b>Status</b>	Approval
<b>Release date</b>

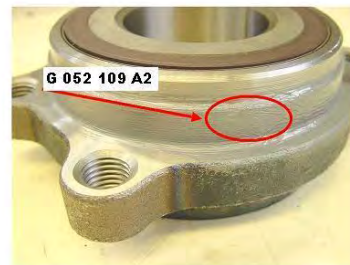
Clicking or clacking noise when manoeuvring or parking.

Normal driving dynamics may cause microscopic movements between the wheel bearing and wheel bearing housing.

**Figure 1.** Area to apply paste.

Using a brush, apply a thin coat of paste **G 052 109 A2** on the wheel bearing housing as shown on the photo.

Do not allow paste to enter the threaded part of the bearing housing
