JTB00539NAS1

TECHNICAL BULLETIN

'Rattle' Noise From Front Overhead Console

MODEL:	MODEL YEAR:	VIN:	ASSEMBLY PLANT:
XJ Range (X351)	2017	V92474-W05397	Castle Bromwich

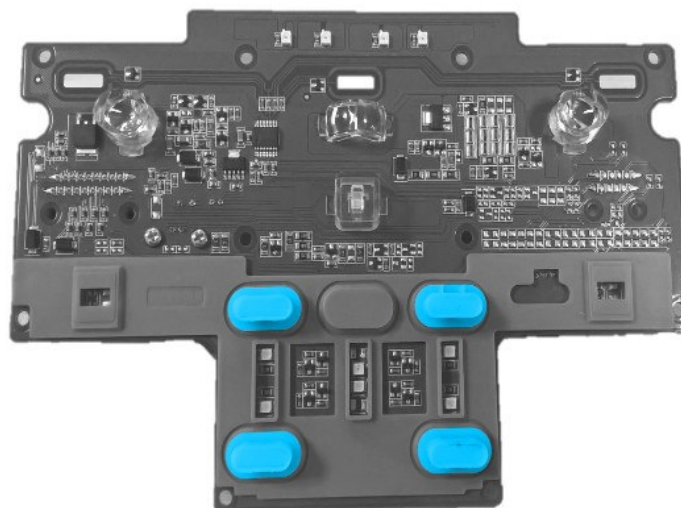
E201555

- The front overhead console may have four or six buttons; four-button version shown.
- White buttons require modification; gray buttons do not require modification.

Visually inspect the color of the four or six front overhead console buttons.

- If all the buttons are gray, this is not the cause of the Customer's concern.
 - Go to step 9.
- If any of the buttons are white, go to Step 5.
