K404 UPS4616-5BNAS1

TECHNICAL BULLETIN

13 DEC 2016

Update Prior to Sale: V6 Petrol Coolant Hose Chafe

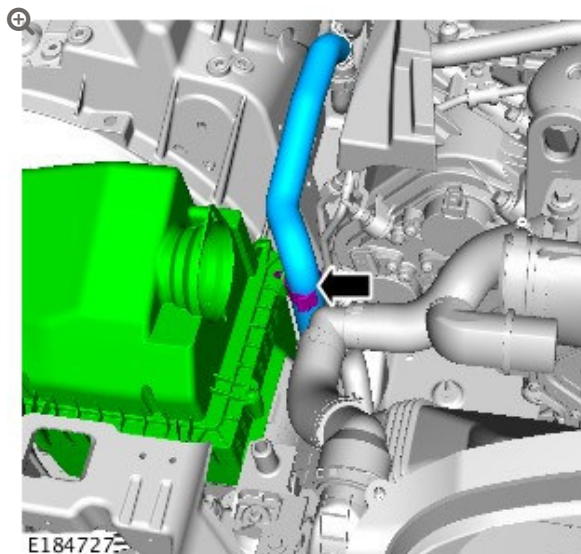
Check that the fir tree clip for the coolant hose is installed and located and secure on the right-hand air cleaner.

- If the fir tree clip for the coolant hose is installed on the right-hand air cleaner and securely attached to the coolant hose, release the vehicle.
 - No further action required.
- If the fir tree clip for the coolant hose is installed on the right-hand air cleaner and not securely attached to the coolant hose, check the coolant hose for damage.
 - If the coolant hose is not damaged, latch the coolant hose into the fir tree clip, and release the vehicle.
 - No further action required.
 - If the coolant hose is damaged, continue to Step 3.
