TECHNICAL BULLETIN

JTB00528NAS1

'Creak' / 'Click' Noise From 'A' Pillar or Front of Roof Opening Panel

XF (X260)

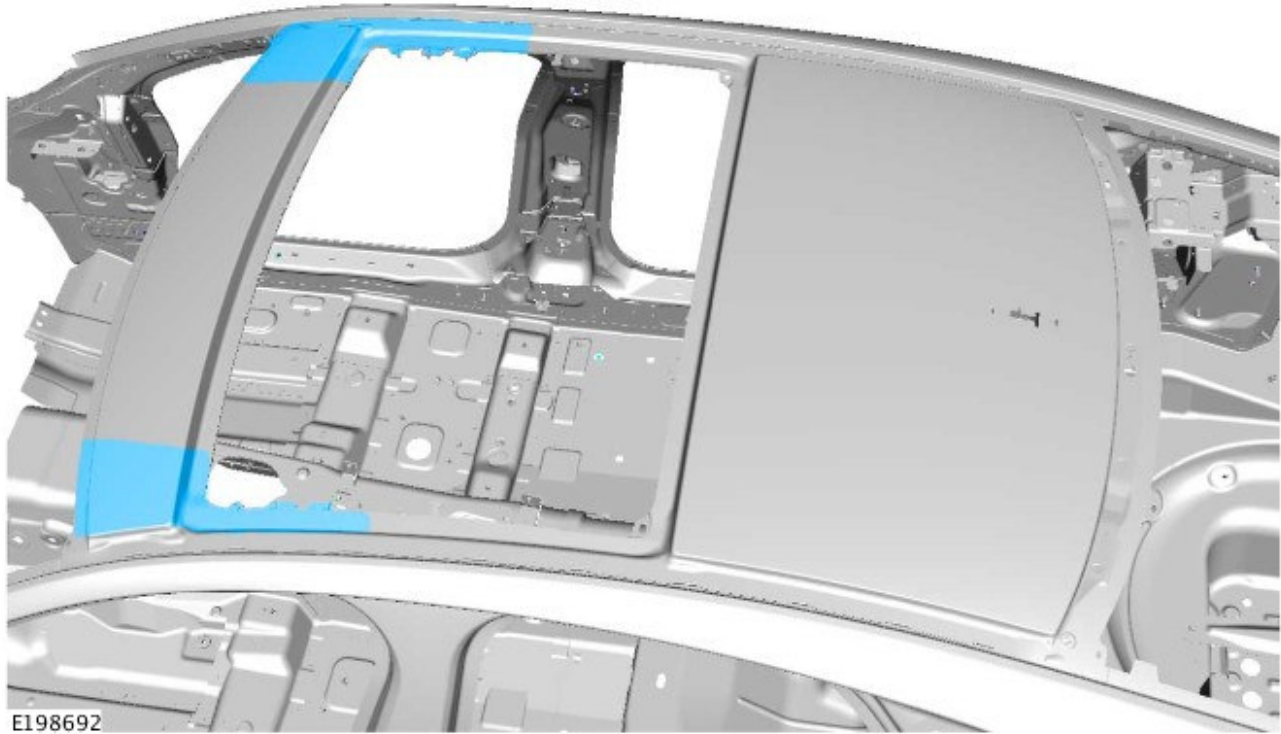
1. Component location.

Situation: A 'click' / 'creak' noise may be evident from the top of the 'A' pillar area or the front of the roof opening panel.

Cause: This may be caused by E-coat bonding and panel interference, made worse by flexing of the panels.
