TECHNICAL BULLETIN

K415NAS1

Service Action: Water Ingress - Left Hand A Post

XE (X760)

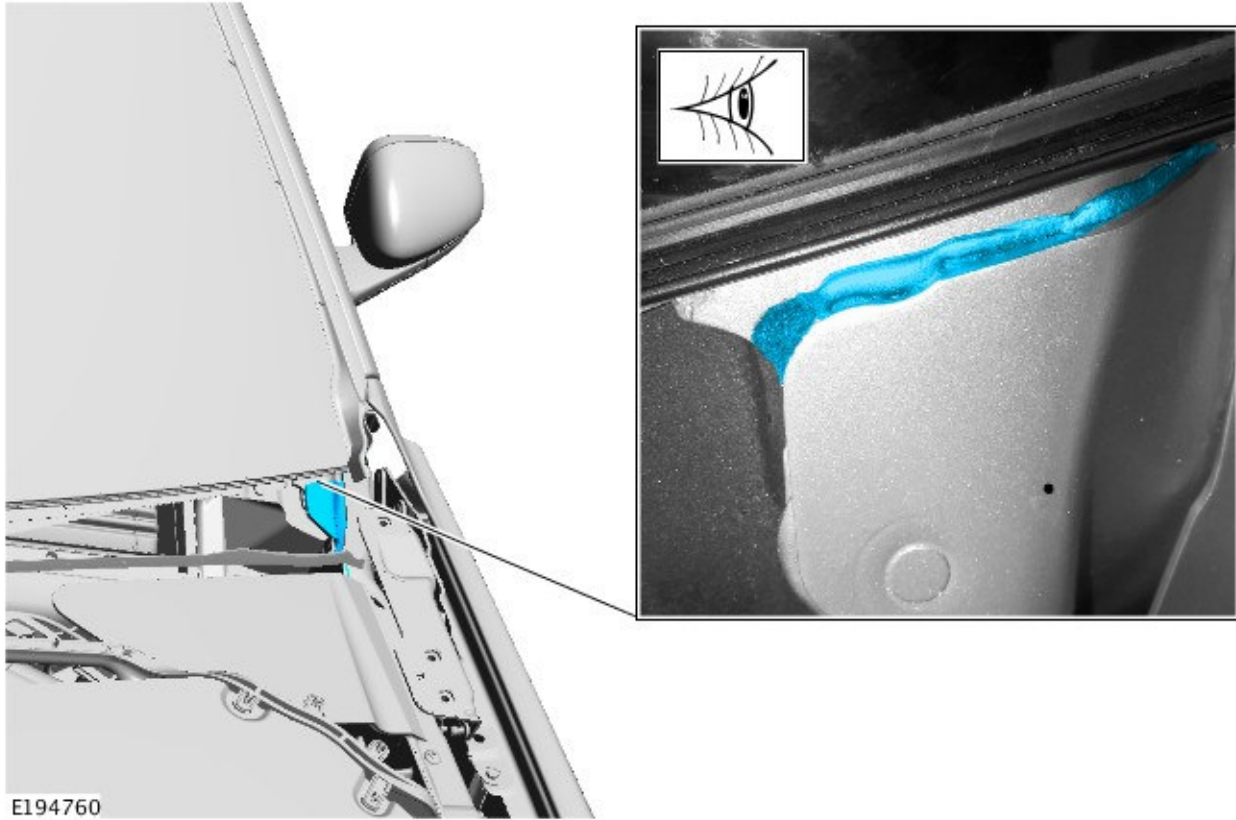
Visually check to see if the sealant is applied in the area shown.

- If the sealant is applied, no corrective action is required.

- Install the cowl panel vent screen (see TOPIx Workshop Manual section 501-02: Front End Body Panels).
- Release the vehicle for onward distribution or sale.
- If the sealant is not applied, go to Step 3.

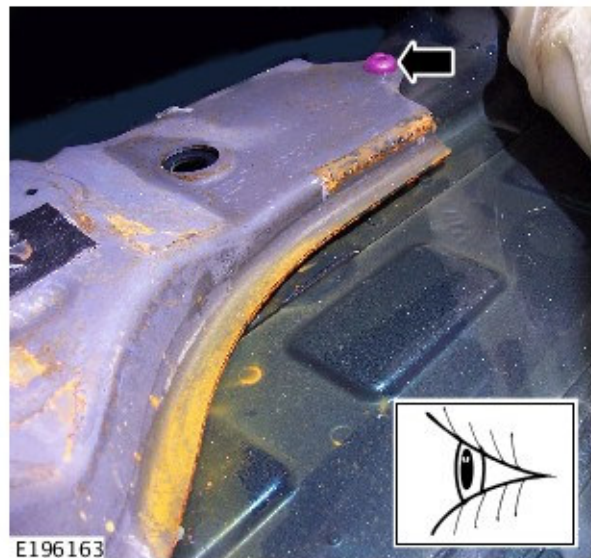
19. Visually inspect the body brace for corrosion.

- If no corrosion is evident, go to step 20.
- If corrosion is evident, remove the body brace fixing and remove the body brace.
- Remove any corrosion with a wire brush or similar tool.
- Clean both sides of the body brace with a spirit wipe cloth.
- Paint both sides of the body brace with etch primer and allow to dry.
- Paint both sides of the body brace with finish coat and allow to dry.
- Install the body brace and fixing.

- Torque **40 Nm**
