TECHNICAL BULLETIN K445NAS1 16 NOV 2016

SECTION: 303-03

Service Action: Coolant Level Check

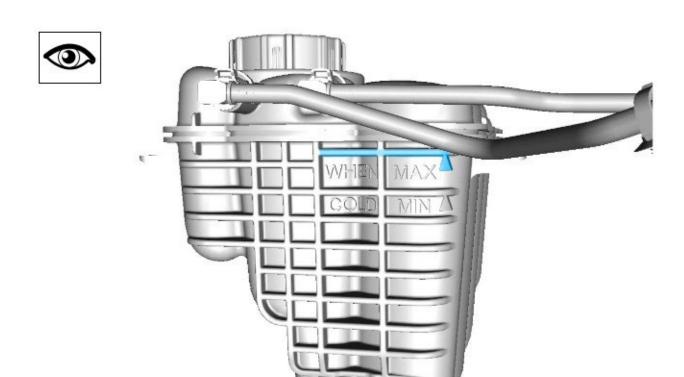
E199531

Visually check the coolant level in the coolant expansion tank.

- If the engine coolant level is at maximum (MAX), go to step 3.
- If the engine coolant level is below maximum (MAX), top up the engine coolant expansion tank (see TOPIx Workshop Manual section 303-03: Engine Cooling Cooling System Draining, Filling and Bleeding).
