SERVICE BULLETIN

APPLICABILITY: 2015-2017MY WRX and STI Models

SUBJECT: Headlamps- Design Change to Prevent

NUMBER: 07-111-16

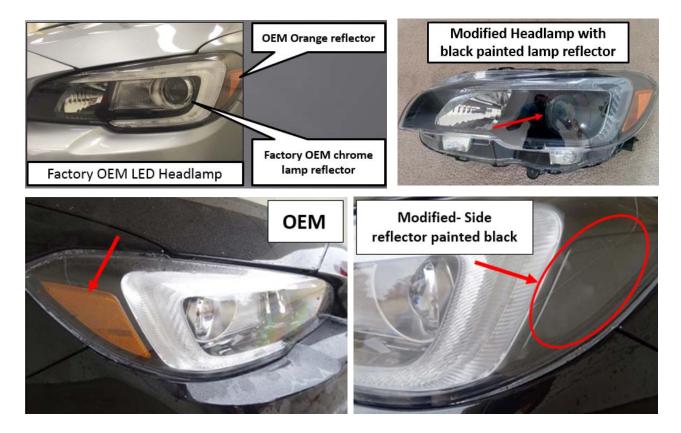
Inspect the headlamp assemblies closely to confirm they have not been modified and that they are Genuine Subaru (OEM) parts and not aftermarket replacement units. Photos comparing the OEM part to examples of modified headlamps are provided below. Modified headlamps are not warrantable.

Whenever replacing a headlamp assembly, always follow all the procedures in the applicable Service Manual. In addition, pay close attention to the front bumper fascia R&R along with the headlamp and fog lamp aiming procedures (where required). Replace only the affected headlamp assembly if this concern is duplicated.
