SERVICE BULLETIN

APPLICABILITY: 2014-2016MY Forester

NUMBER: 12-204-16R

SUBJECT: Pop, Click, Creak Sounds from the Rear Body Area

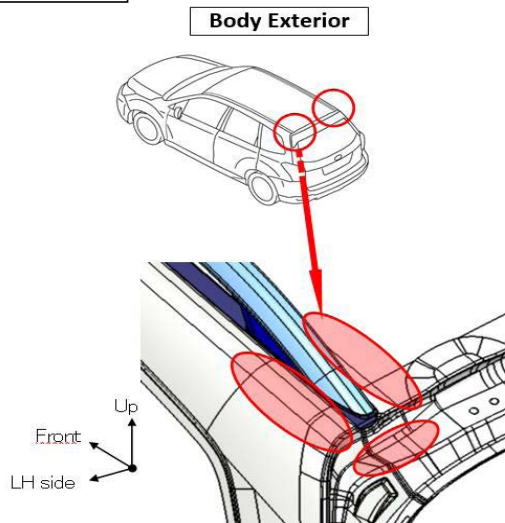
Figure 1

Using a set of chassis ears, check the areas circled in red in **Figure 1** above, the roof rail ends and stepped portions of the roof panel (the left side shown but always check both sides) for the sound. If the vehicle is not equipped with roof rails, check the areas at the ends of the roof moldings along with the stepped portion where the rear gate hinges are secured.

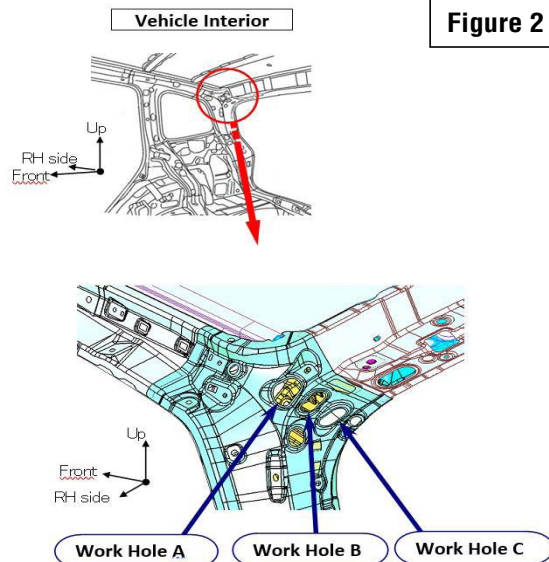
Figure 2

In **Figure 2** above, the term “Work Hole” is used for the access points where chassis ears can be inserted to help isolate the source(s) of the sound. Tools can be inserted into these holes where accessible to separate the layers of sheet metal and reduce or eliminate welding spatter by using a hammer and flat-nosed punch in other spot weld areas. Use the photo below to identify the work holes.

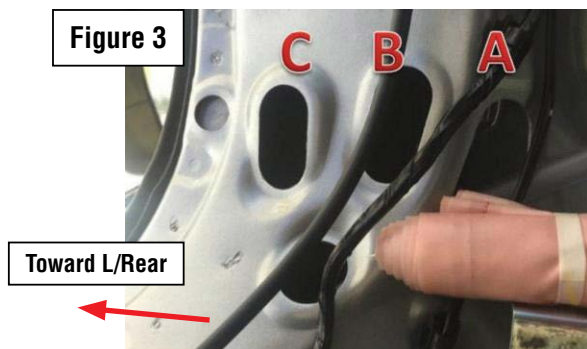
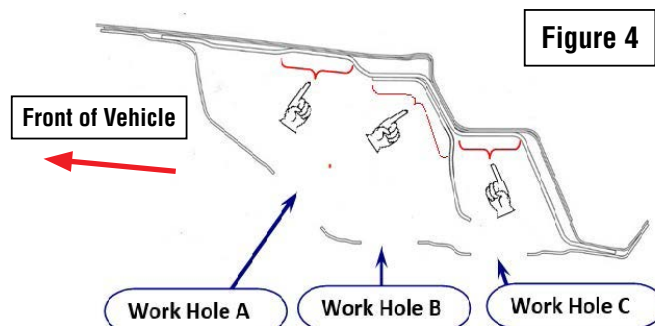
Figure 3 below shows arrangement of the Work Holes and **Figure 4**, a cross-section view of how the sheet metal is layered in the suspect areas.

By working through the Work Holes, separate the layers (enlarging the gap) of sheet metal as shown in the procedure steps below. In areas where the edges of the metal layers are not accessible to separate, use a hammer and flat-nosed punch around the spot welds in the starred areas as shown in Steps 2 and 3 below to gain some separation. **SPARINGLY** apply a SMALL amount of the Endura penetrating grease into any new gaps created using the aerosol applicator tube. Always inspect for any weld spatter and crush or remove it as best as possible with either a flat blade screw driver or a “modified” tool as shown in the example photo below.

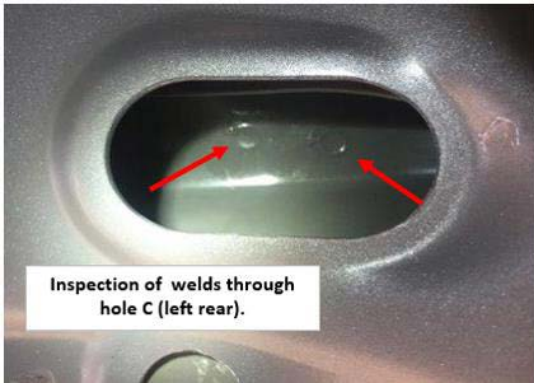
Inspection of welds through hole C (left rear).

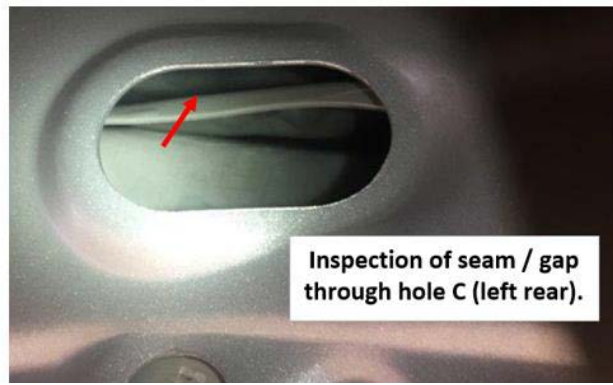
Inspection of seam / gap through hole C (left rear).

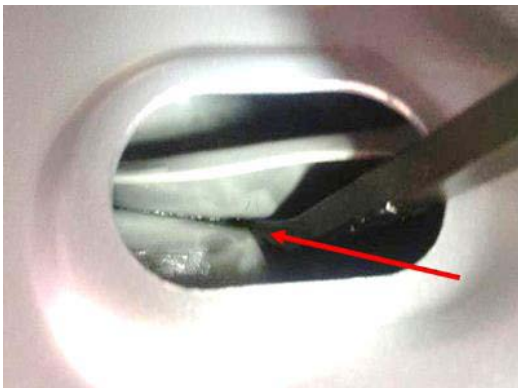
Photo shows weld spatter between layers of sheet metal.
