## SERVICE BULLETIN

**APPLICABILITY:** 2012-16MY Impreza 2.0L Models  
 2015MY-2016MY WRX and STI Models  
**SUBJECT:** Rattling Sound from Rear Package Shelf Area

**NUMBER:** 12-189-15R  
**DATE:** 09/23/15  
**REVISED:** 07/26/16

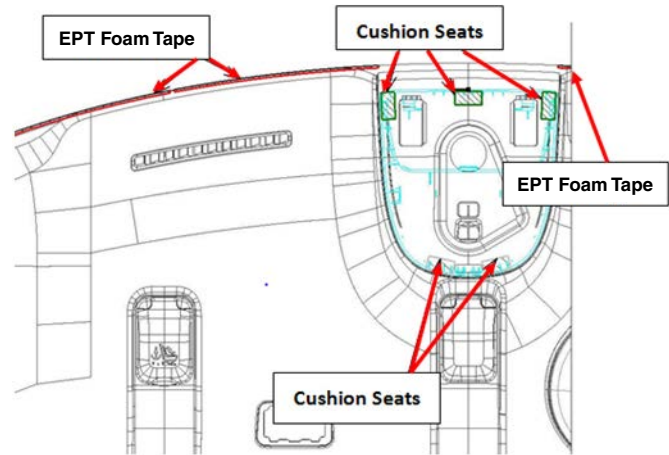
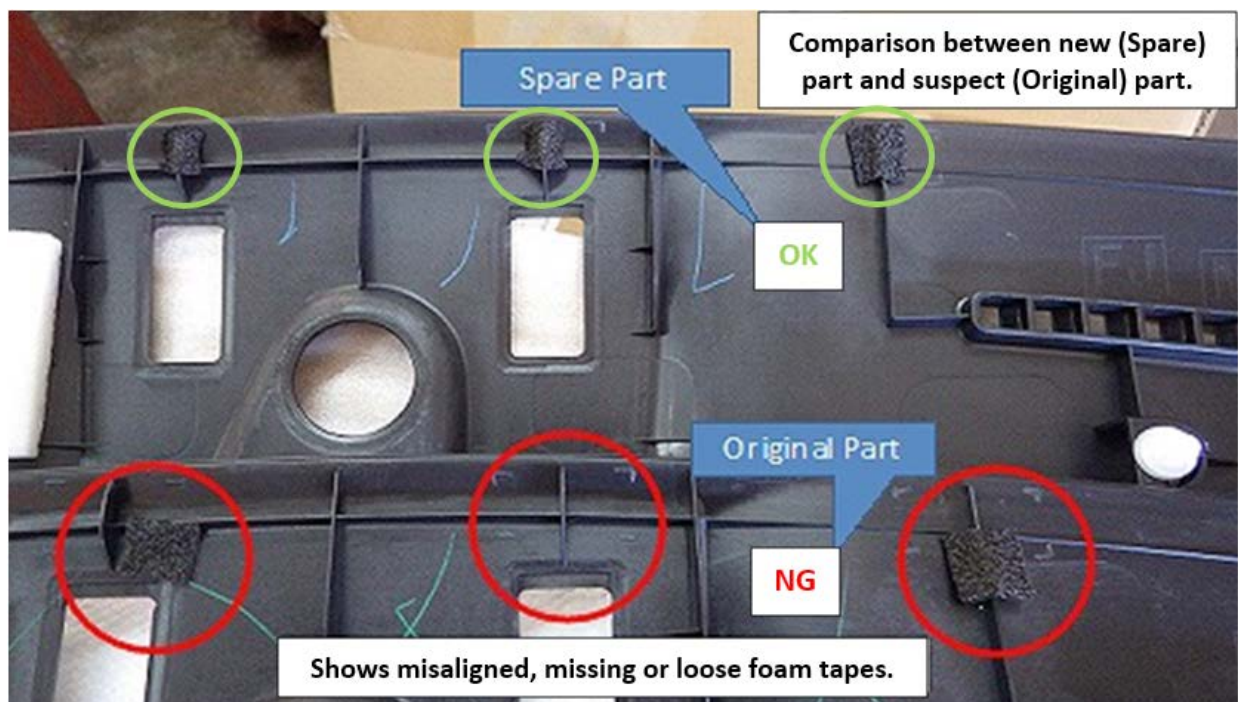
The changes made to the new shelves include:

- addition of 5 non-woven tape “cushion seats” in the area of the center stop lamp
- EPT foam tape added along the rear edge of the shelf to insulate it from contacting the rear glass.
- EPT foam tape added to the ribs and stands which are molded into the underside of the package shelf to insulate them from the vehicle body.
