## SERVICE BULLETIN

**APPLICABILITY:** 2014-15MY Forester

**NUMBER:** 12-205-16

**SUBJECT:** Procedure to Eliminate a Depression or Dent in the Roof Trim Panel (Head Liner)

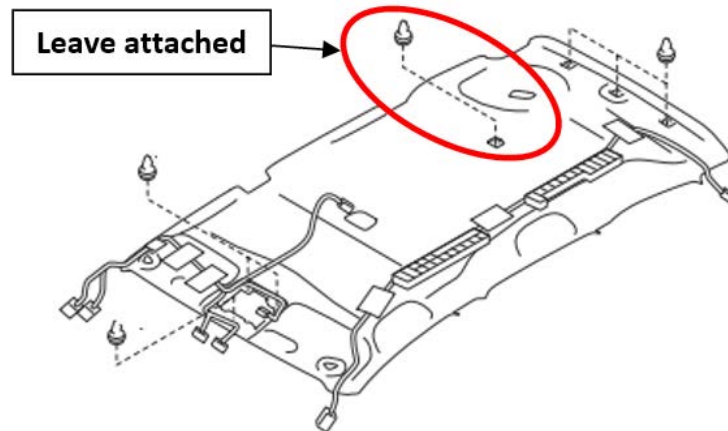
- Remove the weatherstripping from the body flanges at the top areas of all 4 doors and rear gate opening.
- Using a trim clip removal tool, **CAREFULLY** separate the trim clips from the front and rear areas of the head liner leaving only the center rear retaining clip still attached as shown below.

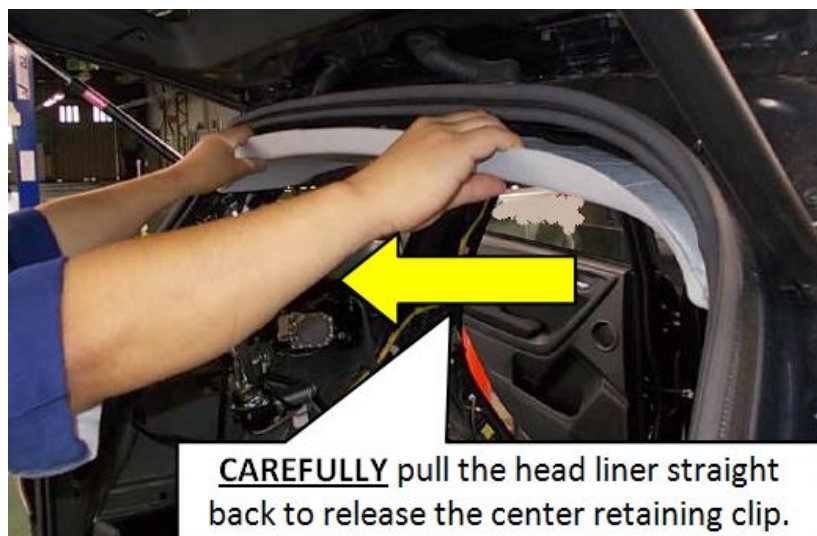
**Step 3-** **CAREFULLY** pull the head liner straight back which will release the center retaining clip from the bracket as shown below. Remove and discard the retaining clip. Use a helper to keep the head liner supported.

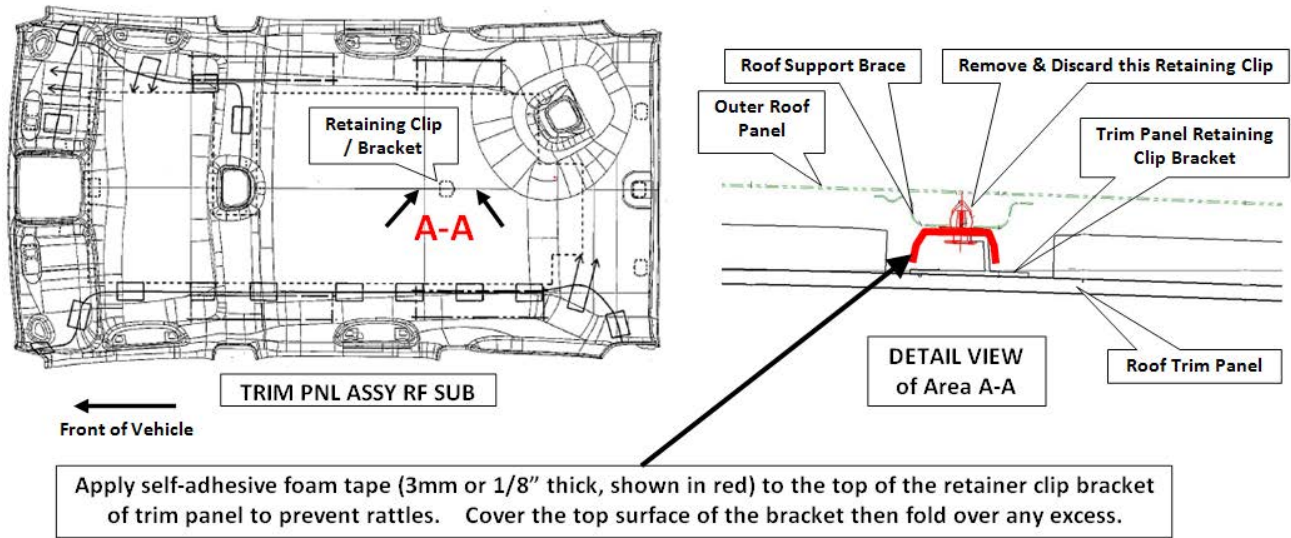
This bulletin provides a procedure to address a limited number of customer concerns regarding a visible depression or dent which may be noticeable in the roof trim panel (head liner) over the front, center portion of the cargo area.

The illustrations below show a drawing of the head liner with the location and detail of the retainer clip bracket and attachment point to the roof brace which is where the depression can occur.

**Step 4-** Install a piece of 3mm (1/8” thick) self-adhesive foam tape to insulate the retainer clip bracket from the roof brace as shown in **DETAIL VIEW of Area A-A** above.
