SERVICE BULLETIN

APPLICABILITY: 2015-2017MY Legacy and Outback
 2012-2016MY Impreza
 2013-2016MY XV Crosstrek
 2015-2016 WRX / WRX STI
 All Models Listed with Seat Lifter Feature

NUMBER: 12-206-16
DATE: 07/28/16

SUBJECT: Seat Cushion Frame Surface Rust Treatment Procedure

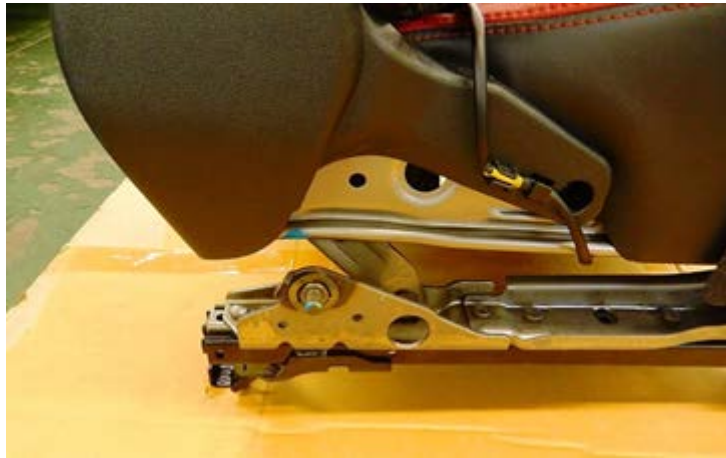
This bulletin provides a procedure to address a customer reported cosmetic condition of surface rust appearing on the inner seat cushion frame of the front seat assemblies.

- Remove the rust from the areas indicated in the illustration above using Scotch Brite, emery cloth and/or sandpaper as necessary.

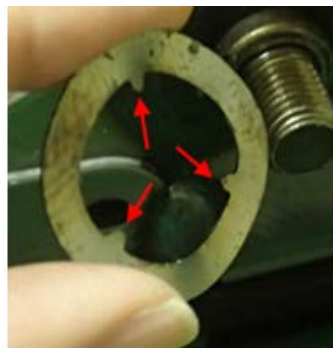
OLD Wave Washer

NOTE: If the wave washer used for the seat belt buckle is found to be the old “tang” type, replace it with the new style washer **p.n. 64168SG000** as shown in the photos below.
