SERVICE BULLETIN

APPLICABILITY: 2015-2016MY Legacy and Outback
 2015-2016MY Impreza and XV Crosstrek
 2016MY Forester
 2016MY WRX

NUMBER: 15-198-16R
DATE: 05/02/16
REVISED: 07/08/16

SUBJECT: Reprogramming File Availability to Address Operational Concerns with “Gen 2” Fujitsu-TEN (F10) Navigation and 7” Display Audio Units

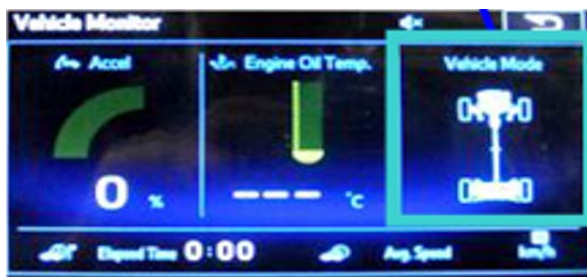
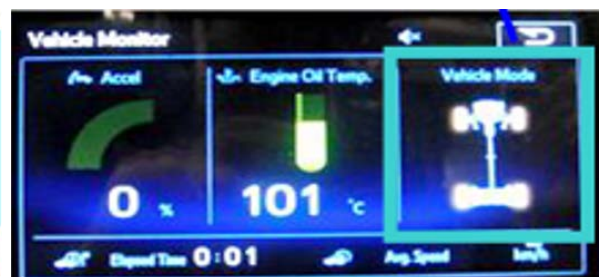
- Logic change to provide a “_” (underscore) character on the keyboard.
- Logic change to match the engine oil maintenance remaining mileage on the maintenance reminder screen to the odometer meter value on the combination meter when mileage unit is set to read in “KM”.
- Logic change to insure the Vehicle Mode indicator on the Vehicle Monitor screen matches the actual vehicle status. Example: The wheel indicators on the vehicle monitor screen no longer stay illuminated indicating VDC is “active” after VDC activation is complete.

VDC “Inactive”

VDC “Active”

This bulletin announces reprogramming file availability and the software installation procedure to address a group of operational concerns received from the field listed below involving “Gen 2” F10 Navigation and Display Audio units with 7” display. The procedure will involve downloading the applicable software update files from Subarunet then loading them onto a flash drive for audio unit installation. It is important to read through and understand this information **completely** before proceeding.
