Section Theft Deterrent/Keyless Entry Market USA

L-SB-0084-16 September 30, 2016 Page 4 of 5

Remote Engine Starter (RES+) ECU Update from 2G to 3G

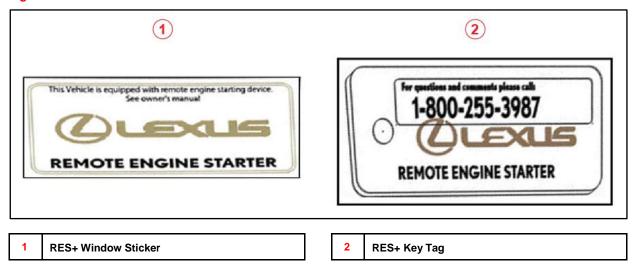
Figure 1.

- Look for RES+ window stickers on the driver or passenger front window glass.
- . Look for RES+ key tag on the Smart Key ring.
