## Analog Cluster Instruments with Stepper Motor (Family MW2000)

Customer Communication

Wire Peel of Tin (Sn)

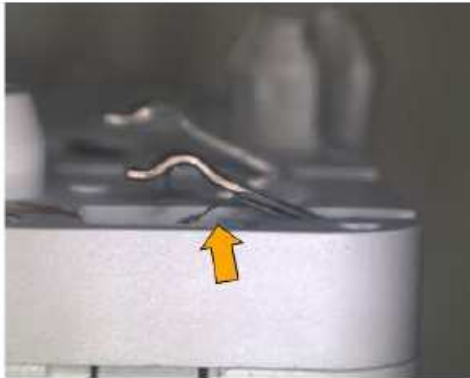
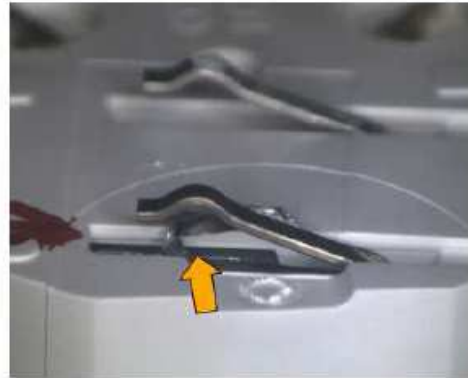
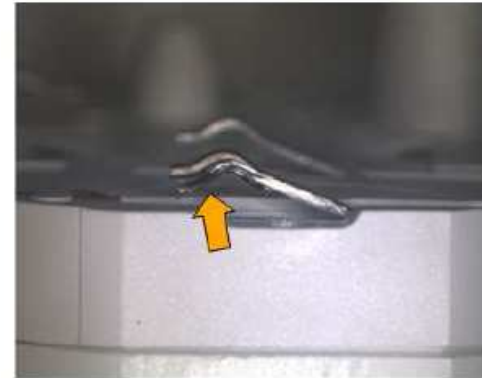
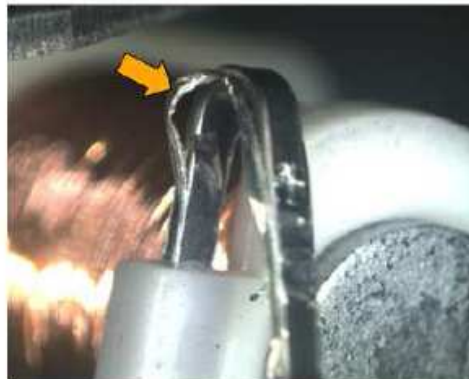
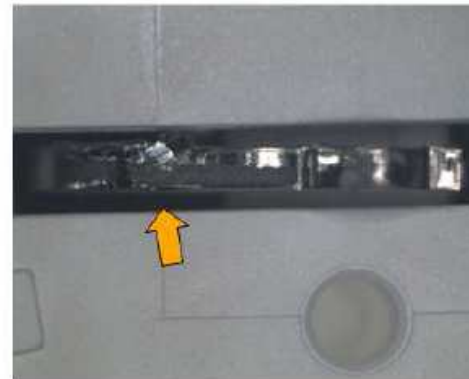
## Image of failure mode

1. Peel of tin (Sn) surface at contact wire (connection of stepper motor to PCB and inside stepper motor)
2. Suspicious "Contact Wire" delivered from sub-suppliers Stenzhorn and coating company Edelhoff.

- External supplier sent to Continental one batch of nok flat-wire material. Potential root cause: Abnormality of galvanic layer stack between nickel and tin layer.
- Nok flat-wire was partly consumed at Babenhausen plant for stepper motor production.
- Issue was identified at stepper motor assembly line.
- Supplier was informed about the issue.

- Potential risk of:
  - Pointer malfunction → blocking motor (blocking particle).
  - Pointer malfunction → contact problem board to stepper.
  - Malfunctions → short on cluster-PCB (by peeled off particles).
- Babenhausen sorted out of 600,000 blocked Stepper Motors. 59 nok as of November 4.  
-> sorting is ongoing.
- **No failed** stepper motors in final assembly lines cluster instruments at Continental found.

- Affected suspect stepper motor deliveries are identified and communicated to all Continental locations.
- Blocking of suspect stepper motors within Babenhausen plant was performed. Sorting activities for risk evaluation are ongoing.
- Blocking of suspect stepper motors world wide is initiated.
- SQM and Process Technology are currently present at supplier for investigations on root cause.
- EDX analysis is running.
- Identification of affected cluster instruments - world wide – will be provided by the delivering plant of assembled clusters.
- Environmental and functional testing is underway, no issues found to-date.
