# Service Bulletin

**Subject:** No Crank / Start Then Immediate Stall / SES MIL / Service 4WD / Relay Clicking / Rearview Camera Inop / DTC (Inspect Ignition 1 voltage)

**Models:** 2015-2017 Cadillac Escalade Models  
2014 Chevrolet Silverado 1500  
2015-2017 Chevrolet Silverado, Suburban, Tahoe  
2014 GMC Sierra 1500  
2015-2017 GMC Sierra, Yukon Models

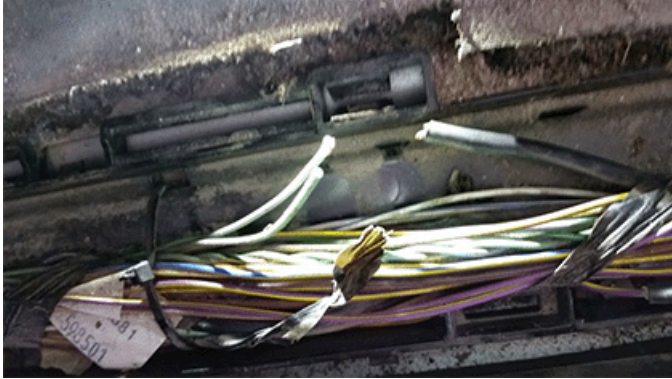
3. Circuit 5199 under the driver's sill plate for being damaged/corroded, as shown below.

Repair any wiring / terminal issues using the appropriate SI wiring repair documentation.
