Service Bulletin

Subject: Diagnostic Tip - Adaptive Cruise Temporarily Unavailable

Models: 2015-2017 Cadillac Escalade Models
With Driver Assist Package (RPO Y66)

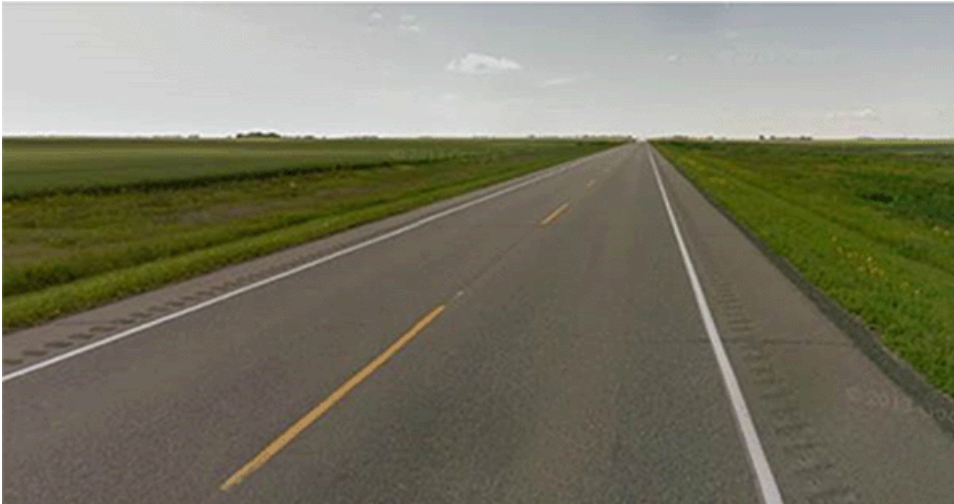
- Barren Environments: As part of the blockage detection algorithm, the radar may conclude it is blocked if the radar does not "see" anything over a period of time. This can happen when driving in very bare environments, such as deserts and rural areas where there are no large objects to detect like other vehicles, bridges, building, trees, signs, mail boxes, guard rails, etc. Below is an example photo of an area where the radar may determine a blockage because there are no objects in the environment for the radar to "see". In these cases, if the system does not detect an object within approximately 60 seconds or 1.2 miles (2 km) the cruise will be disengaged and a "ADAPTIVE CRUISE TEMPORARILY UNAVAILABLE" message. If there were other vehicles on the road for the radar to detect there would not be any issues.

. Because of this, it may appear to be an intermittent concern to the customer, and difficult for a dealership to duplicate

- Update for Barren Environment: The Long Range Radar (LRR) Module software has been updated to address barren environment performance concerns for the 2015/16/17 Escalade models. Reprogram the LRR module with the latest software available in TIS2WEB.

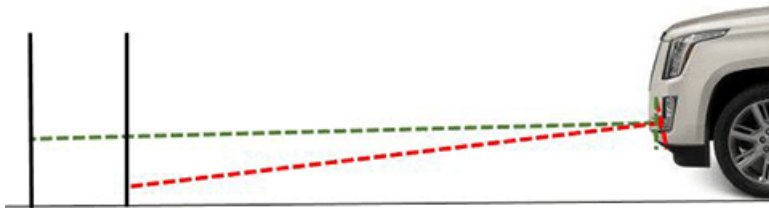
The Long Range Radar Module is scanning for objects up to 656 ft (200 m) in front of the vehicle as represented by the green line in the illustration below. Even the slightest bend in the radar bracket will cause the radar not to be able to "see" objects farther out from the vehicle as represented by the red line in the illustration below. If the Long Range Radar cannot "see" objects throughout the full range of 656 ft (200 m), it will determine the radar is blocked and disable the cruise along with the GDS relearn procedure will not complete, or it may fail or error out when it is performed. DTC B101E 4B can set if the radar cannot "see" objects throughout the full range of 656 ft (200 m) when performing a learn.

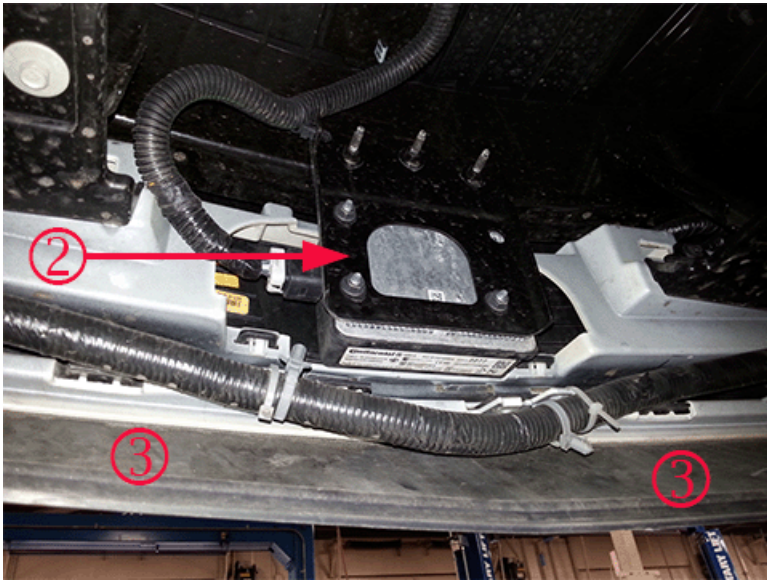
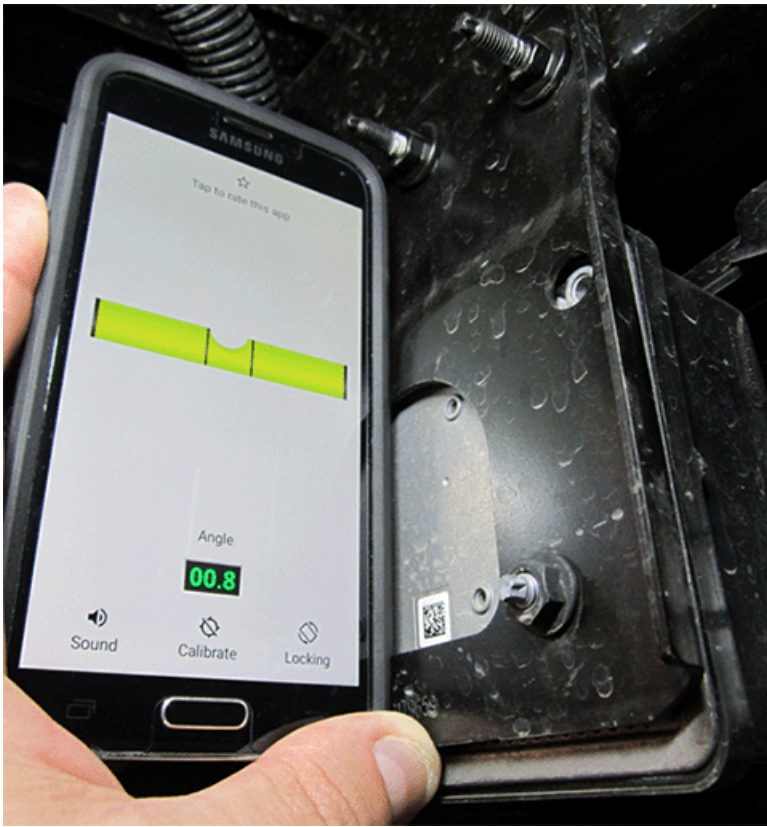
- Radar Bracket Inspection: Physically check the Long Range Radar Module bracket (2) to make sure it is in alignment. Place the truck on an alignment rack to ensure a flat, level surface. Use an angle gauge/level to make sure the bracket is mounted 90 degrees (+/- 3 degrees) to the level alignment rack.

. Position a digital angle gauge/level on the long range radar bracket behind the module and check the vertical alignment, as shown below. The Long Range Radar Module must be mounted straight up and down vertically +/- 3 degrees. If misaligned, the Long Range Radar Module bracket is not adjustable and the mounting bracket is most likely bent and will need to be replaced.

After the Long Range Radar Module alignment has been checked and/or corrected, perform the Long Range Radar Learn in GDS by following the Radar Sensor Module - Long Range Programming and Setup procedure in Service Information.

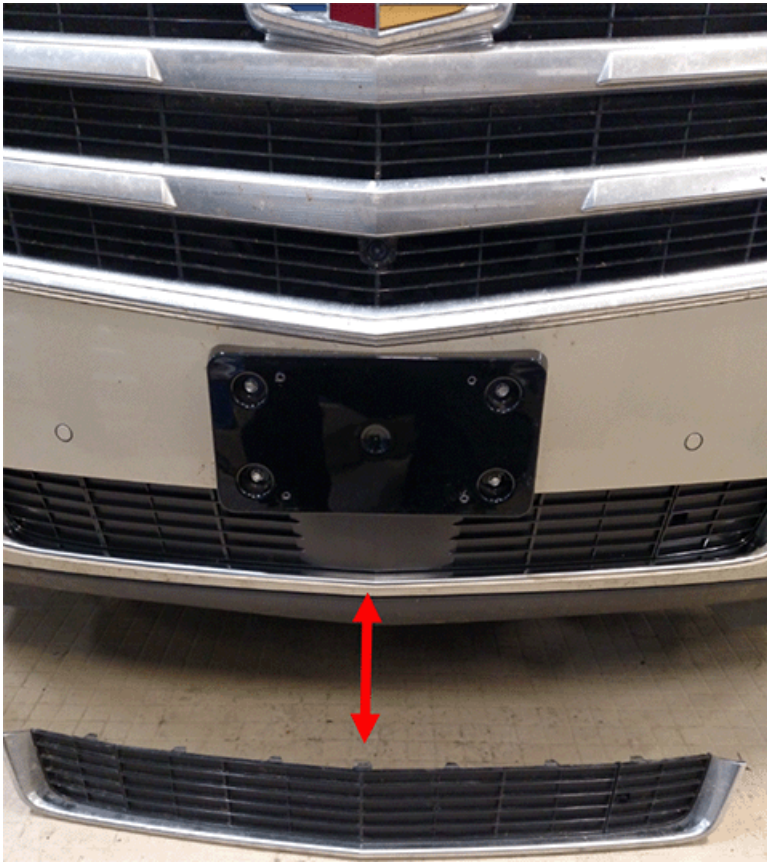
Below is an example of the wrong factory OEM front lower grille molding that was installed. The long range radar module is located behind the lower grille molding. The wrong lower grille molding (the one on the floor) had been installed on this vehicle. The long range radar module could not "see" through the molding correctly and would detect a blockage and disable the cruise. The correct lower grille molding (the one shown on the truck) was installed on the truck, which corrected the concern.
