# Service Bulletin

**Subject:** Creak Click Pop Crack Type Noise From Front Suspension/Frame Area While Making Turns

Brand:	Model:	Model Year:		VIN:		Engine:	Transmission:
		from	to	from	to		
Cadillac	Escalade Models	2015	2017	All	All	All	All
Chevrolet	Silverado, Suburban, Tahoe	2015	2017	All	All	All	All
GMC	Sierra, Yukon Models	2015	2017	All	All	All	All

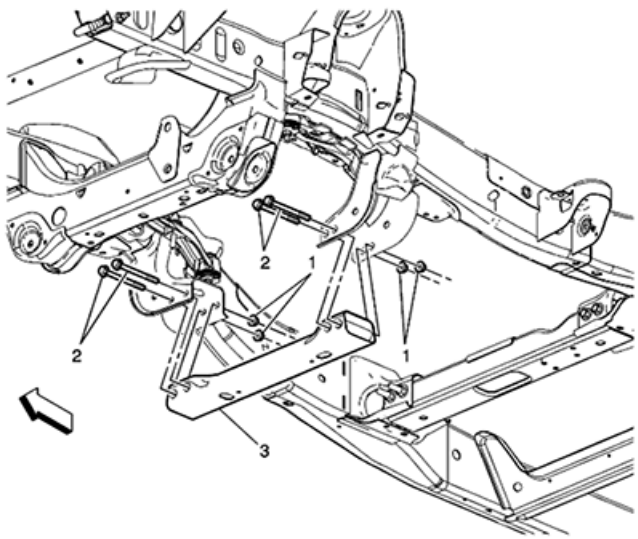
<b>Involved Region or Country</b>	North America
<b>Condition</b>	<p>Some owners may comment of a creak, click, pop, crack type noise from the front suspension or front frame area while making tight turns. It may also be noted the noise can be felt in the foot well area</p>

To correct this concern loosen and then retorque the four front frame crossmember bolts/nuts:

1. First Pass: 70 Nm (52 lb ft)
2. Final Pass: 110 degrees
