# Service Bulletin

**Subject:** Service Front Camera / Service Lane Departure Warning / Service Lane Keep Assist Message with DTC B1008 SYM4B

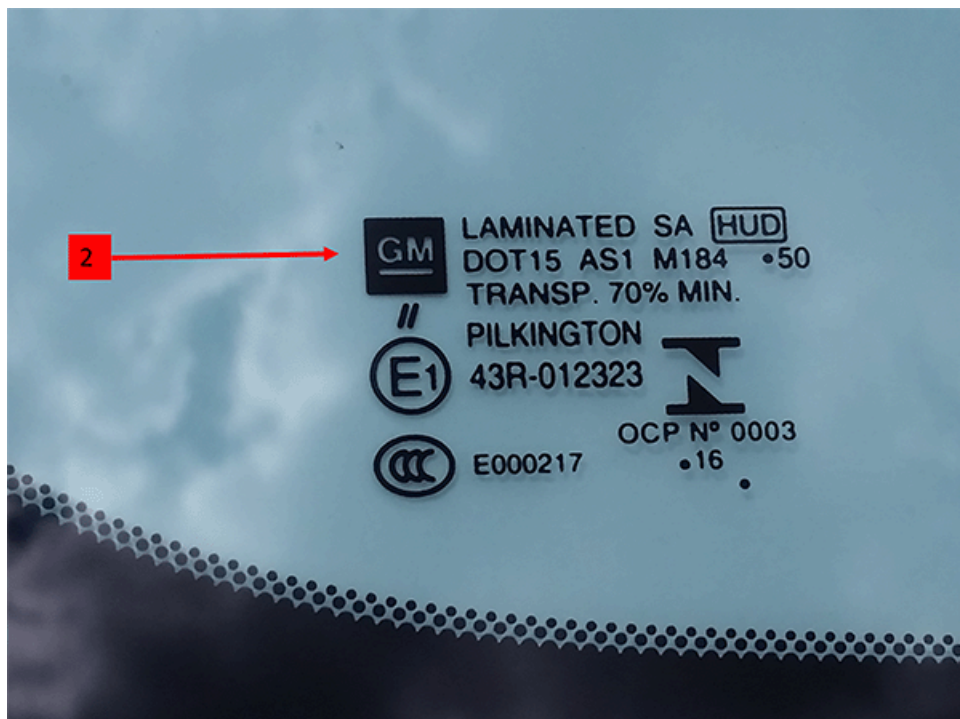
If, after performing the checks listed above and the root cause of the camera not completing the calibration/learn is not found, inspect for an aftermarket windshield being installed in the vehicle. To determine whether or not the windshield is an aftermarket or factory windshield, inspect for the "GM" Logo in the lower right corner of windshield, as shown below (2). If the "GM" Logo is not present, then the windshield is aftermarket.

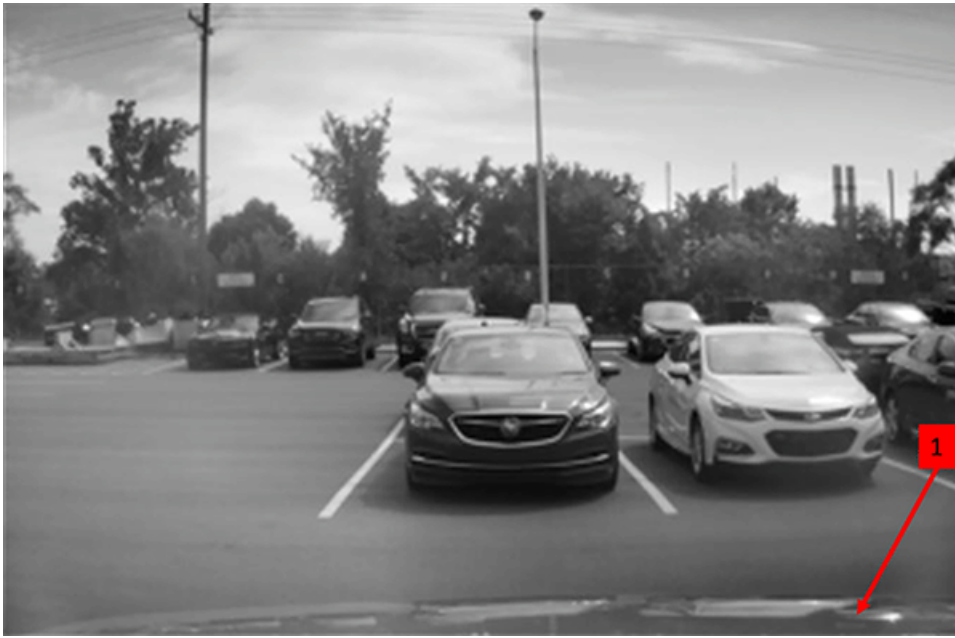
It has been found that some aftermarket windshields do not properly mount/position the front view camera. Shown below are some images, taken with engineering tools (see note below), of what the front view camera is actually seeing. The first image is taken from a truck with an aftermarket windshield. As shown below, the camera is seeing part of the hood (1). Because of this, the camera is not seeing movement in the area of the hood and can not complete the learn. The second image below is from a truck with a factory windshield and there is no hood seen by the front view camera.
